Access Compliance Report

Public Rights-of-Way

(Curb Ramps)

Intersection ID: 14662	Main Street: S_KINGS_DR	Cross Street: BALDWIN_AV	Location: SE
ADA ID: CB216F183DD6	Ramp Type: Directional1	Initial Pass/Fail: Fail	Overall Compliance: No
Severity Score: 12.5			
Codes/Mitigation Info/Possible Solution		Field Measurements/Component Compliance

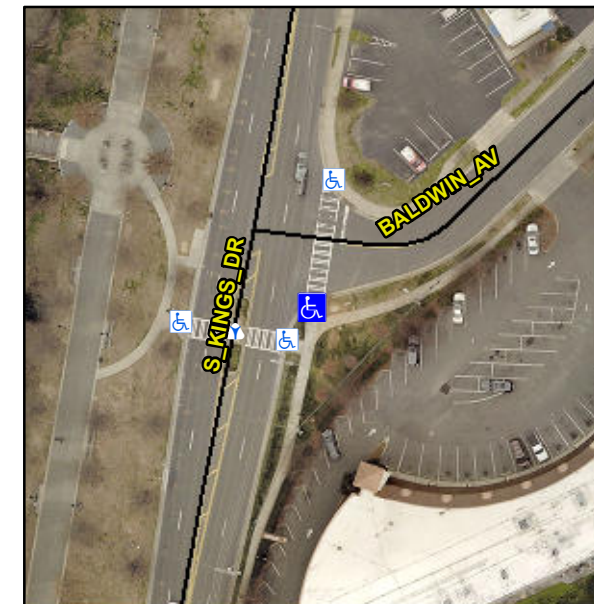
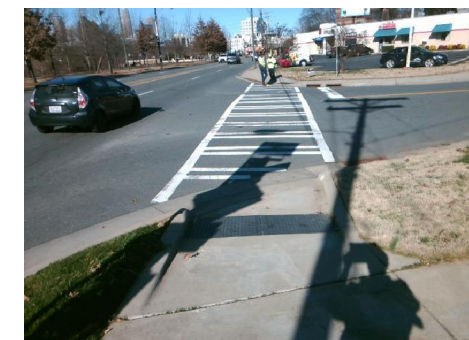
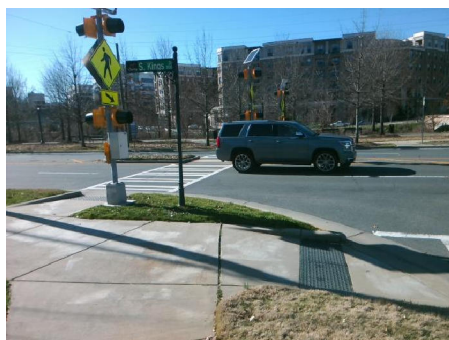
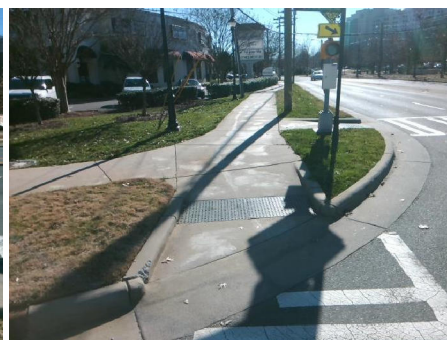
R304.2.2

Compliance	Description	Data	Compliance	Description	Data
N/A	Ramp Length (in)	78.0	N/A	Grade Break?	N/A
Yes	Ramp Width (in)	70.0	N/A	Grade Break Slope (%)	0.0
No	Ramp Slope (%)	9.6	N/A	Grade Break XSlope (%)	0.0
Yes	Ramp XSlope (%)	0.6			
N/A	Flare Type LT	N/A	N/A	Flare Type RT	N/A
N/A	Flare Slope LT (%)	N/A	N/A	Flare Slope RT (%)	0.0
N/A	Flare Traversable LT?	N/A	N/A	Flare Traversable RT?	N/A
N/A	Landing Length (in)	0.0	N/A	DWS Provided?	N/A
N/A	Landing Width (in)	0.0	N/A	DWS Contrast?	N/A
N/A	Landing Slope (%)	0.0	N/A	DWS Length (in)	N/A
N/A	Landing X Slope (%)	0.0	N/A	DWS Full Width?	N/A
N/A	Landing Curb? (Y/N)	N/A	N/A	DWS Offset LT (in)	N/A
N/A	Shared Landing?	N/A	N/A	DWS Offset RT (in)	N/A
N/A	Gutter Ponding?	0.0	N/A	Gutter Slope (%)	N/A
N/A	Gutter Lip Ht (in)	0.0	N/A	Gutter X Slope (%)	N/A
N/A	Painted X Walk1?	Yes		Road Slope (%)	1.2
	X Walk 1 Direction	To N		Road X Slope (%)	1.8
	X Walk 1 Width (in)	99.0		Clear Space?	N/A

X Walk 1 Slope (%)	1.2	N/A	Clear Space to XWalk (in)	N/A
	X Walk 1 X Slope (%)	1.8	N/A	Storm Grate/Utility Hazard?	N/A
N/A	Ramp inside XWalk1?	Yes		Storm Grate/Utility Type	
N/A	Any Obstructions?	N/A			N/A
	Obstruction Type		Yes	Surface Condition? (G/P)	Good
			N/A	Curb Slope (%)	1.5

Remove & Replace Entire Ramp.
