Access Compliance Report

Public Rights-of-Way

(Curb Ramps)

| Intersection ID: 53284 | Main Street: BENFIELD_RD | Cross Street: ROBERT_HELMS_RD | Location: SE |

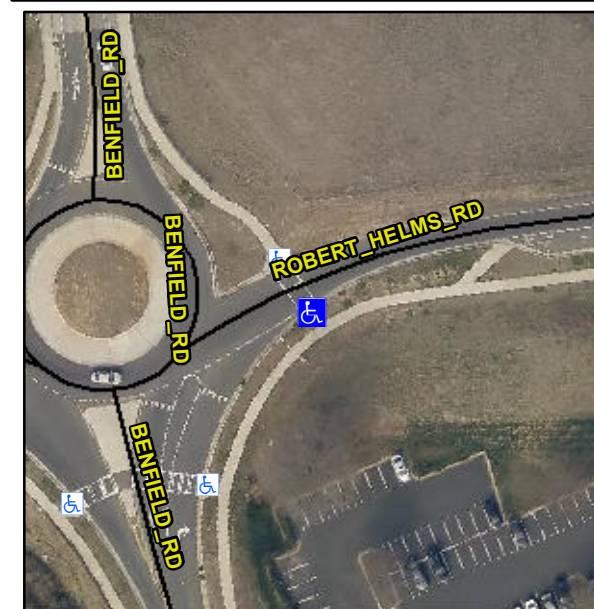
| ADA ID: CB38BDEDDDB51 | Ramp Type: Perp | Initial Pass/Fail: Fail | Overall Compliance: No |
| | | Severity Score: 12.5 | |

R304.2.2

| Compliance | Description | Data | Compliance | Description | Data |
|---|---|---|---|---|---|
| N/A | Ramp Length (in) | 97.0 | No | Ramp Slope (%) | 9.9 |

Possible Solutions:

Remove & Replace Entire Ramp.
