Access Compliance Report

Public Rights-of-Way

(Curb Ramps)

Intersection ID: 53017	Main Street: STEEL_HOUSE_BV	Cross Street: CHARTRES_LN	Location: NE
ADA ID: CB3C1322A45D	Ramp Type: Perp	Initial Pass/Fail: Pass	Overall Compliance: No
Severity Score: 2.5			
Codes/Mitigation Info/Possible Solution		Field Measurements/Component Compliance

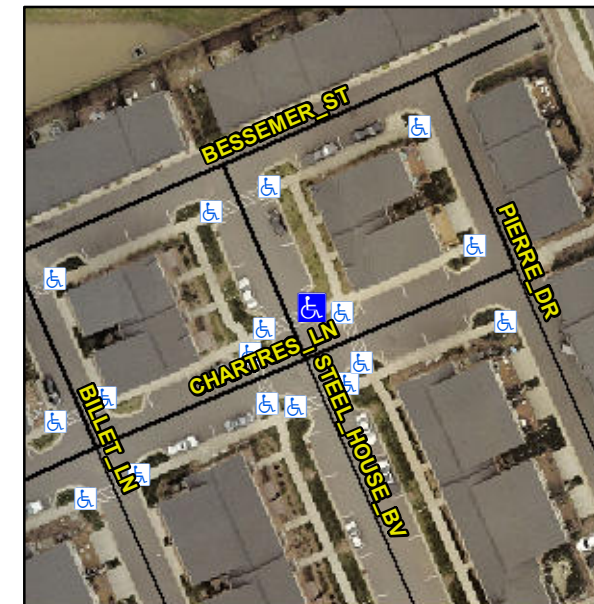
Not Found, R305.1.4, R305.2

Compliance	Description	Data	Compliance	Description	Data
N/A	Ramp Length (in)	139.0	Yes	Ramp Slope (%)	5.7
Yes	Ramp Width (in)	67.0	Yes	Ramp XSlope (%)	0.2
N/A	Flare Type LT	None	N/A	Flare Type RT	N/A
N/A	Flare Slope LT (%)	N/A	N/A	Flare Slope RT (%)	N/A
N/A	Flare Traversable LT?	N/A	N/A	Flare Traversable RT?	N/A
Yes	Landing Length (in)	63.0	Yes	DWS Provided?	Yes
Yes	Landing Width (in)	63.5	Yes	DWS Contrast?	Yes
Yes	Landing Slope (%)	2.0	Yes	DWS Length (in)	24.0
Yes	Landing X Slope (%)	1.6	No	DWS Full Width?	No
N/A	Landing Curb? (Y/N)	No	No	DWS Offset (in)	4.5
N/A	Shared Landing?	No			
Yes	Gutter Ponding?	No	Yes	Gutter Slope (%)	2.4
Yes	Gutter Lip Ht (in)	0.0	Yes	Gutter X Slope (%)	0.6
N/A	Painted X Walk1?	Yes	N/A	Painted X Walk2?	N/A
	X Walk 1 Direction	To SW		X Walk 2 Direction	N/A
N/A	X Walk 1 Width (in)	72.0	N/A	X Walk 2 Width (in)	N/A
	X Walk 1 Slope (%)	1.9		X Walk 2 Slope (%)	N/A
	X Walk 1 X Slope (%)	2.1		X Walk 2 X Slope (%)	N/A

Yes	Ramp inside XWalk1?	Yes	N/A	Ramp inside XWalk2?	N/A
	Road Slope (%)	N/A	N/A	Clear Space?	Yes
	Road X Slope (%)	N/A	N/A	Clear Space to XWalk (in)	N/A
Yes	Any Obstructions?	No	Yes	Storm Grate/Utility Hazard?	No
	Obstruction Type			Storm Grate/Utility Type	
		N/A			N/A
			Yes	Surface Condition? (G/P)	Good

Possible Solutions:

Remove & Replace Entire Ramp.

Total Cost: \$ 1850.00
