# Access Compliance Report

## Public Rights-of-Way

### (Curb Ramps)

Intersection ID: 3544	Main Street: VOLUSIA_CT	Cross Street: WEAVERS_GLENN_PL	Location: E
ADA ID: CB3D9E384701	Ramp Type: PerpDiag	Initial Pass/Fail: Fail	Overall Compliance: No
Severity Score: 33.75

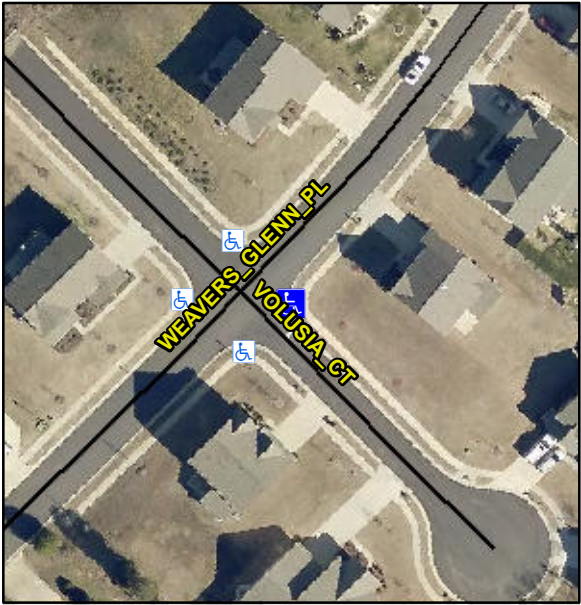
Possible Solutions:		<b>Compliance</b>	<b>Description</b>	<b>Data</b>
	<b>Remove &amp; Replace Curb Ramp With Two New Directional Ramps or Equivalent.</b>		<b>Yes</b>	Ramp Length (in)	48.0
			<b>No</b>	Ramp Width (in)	45.0
			<b>N/A</b>	Flare Type LT	N/A
			<b>N/A</b>	Flare Slope LT (%)	N/A
			<b>N/A</b>	Flare Traversable LT?	N/A
			<b>N/A</b>	Landing Length (in)	N/A
			<b>N/A</b>	Landing Width (in)	N/A
			<b>N/A</b>	Landing Slope (%)	N/A
			<b>N/A</b>	Landing X Slope (%)	N/A
<p>Surveyor Notes:</p> <p><b>N/A</b></p> <p>PROW/ADA:</p> <p><b>Not Found, R304.5.1, R304.5.3</b></p>			<b>N/A</b>	Flare Type RT	N/A
			<b>N/A</b>	Flare Slope RT (%)	N/A
			<b>N/A</b>	Flare Traversable RT?	N/A
			<b>N/A</b>	DWS Provided?	N/A
			<b>N/A</b>	DWS Contrast?	N/A
			<b>N/A</b>	DWS Length (in)	N/A
			<b>N/A</b>	DWS Full Width?	N/A
			<b>N/A</b>	DWS Offset (in)	N/A

<b>N/A</b>	Gutter Ponding?	N/A
			<b>N/A</b>	Gutter Lip Ht (in)	N/A
			<b>No</b>	Painted X Walk1?	No
				X Walk 1 Direction	To NW
			<b>N/A</b>	X Walk 1 Width (in)	N/A
				X Walk 1 Slope (%)	3.8
				X Walk 1 X Slope (%)	6.1
			<b>N/A</b>	Ramp inside XWalk1?	N/A
				Road Slope (%)	10.4
				Road X Slope (%)	2.0
			<b>N/A</b>	Any Obstructions?	N/A
				Obstruction Type	
Total Cost: \$ 3200.00			<b>N/A</b>	Storm Grate/Utility Hazard?	N/A
				Storm Grate/Utility Type	
			<b>N/A</b>		N/A
			<b>Yes</b>	Surface Condition? (G/P)	Good
