## Access Compliance Report Public Rights-of-Way (Curb Ramps)

Intersection ID: 10020108Main Street: ASHLEY\_RDCross Street: N/ALocation:NWADA ID: CB414CEF72E1Ramp Type: PerpInitial Pass/Fail: FailOverall Compliance: NoSeverity Score:10

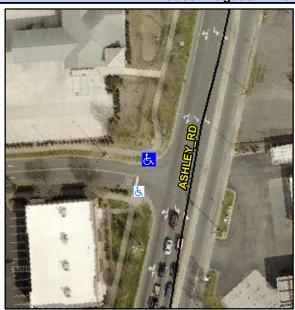
Field Measurements/Component Compliance						
Comp	Compliance Description		Comp	liance Description	Data	
N/A	Ramp Length (in)	72.0	Yes	Ramp Slope (%)	5.7	
No	Ramp Width (in)	47.0	No	Ramp XSlope (%)	4.0	
N/A	Flare Type LT	N/A	N/A	Flare Type RT	N/A	
N/A	Flare Slope LT (%)	N/A	N/A	Flare Slope RT (%)	N/A	
N/A	Flare Traversable LT?	N/A	N/A	Flare Traversable RT?	N/A	
N/A	Landing Length (in)	N/A	N/A	DWS Provided?	N/A	
N/A	Landing Width (in)	N/A	N/A	DWS Contrast?	N/A	
N/A	Landing Slope (%)	N/A	N/A	DWS Length (in)	N/A	
N/A	Landing X Slope (%)	N/A	N/A	DWS Full Width?	N/A	
N/A	Landing Curb? (Y/N)	N/A	N/A	DWS Offset (in)	N/A	
N/A	Shared Landing?	N/A				
N/A	Gutter Ponding?	N/A	N/A	Gutter Slope (%)	N/A	
N/A	Gutter Lip Ht (in)	N/A	N/A	Gutter X Slope (%)	N/A	
N/A	Painted X Walk1?	No	N/A	Painted X Walk2?	N/A	
	X Walk 1 Direction	To S		X Walk 2 Direction	N/A	
N/A	X Walk 1 Width (in)	N/A	N/A	X Walk 2 Width (in)	N/A	
	X Walk 1 Slope (%)	0.5		X Walk 2 Slope (%)	N/A

X Walk 1 X Slope (%)	4.7		X Walk 2 X Slope (%)	N/A	
N/A	Ramp inside XWalk1?	N/A	N/A	Ramp inside XWalk2?	N/A	
	Road Slope (%)	N/A	N/A	Clear Space?	N/A	
	Road X Slope (%)	N/A	N/A	Clear Space to XWalk (in)	N/A	
N/A	Any Obstructions?	N/A	N/A	Storm Grate/Utility Hazard?	N/A	
	Obstruction Type		l	Storm Grate/Utility Type		
		N/A			N/A	
			Yes	Surface Condition? (G/P)	Good

Possible Solutions:	9			
Remove & Replace Entire Ramp.				
	N			
	N			
	N			
	N			
	N			
Surveyor Notes:	N			
N/A	N			
	N			
	N			
	N			
PROW/ADA:	N			
Not Found, R304.5.1, R304.5.3	N			
	N			
	N
