Intersection ID: N/A	Main Street: HARPER_CT	Cross Street: N/A	Location:	N
ADA ID: CB4DADD850B2	Ramp Type: Perp	Initial Pass/Fail: Fail	Overall Compliance: No	Severity Score: 21.25

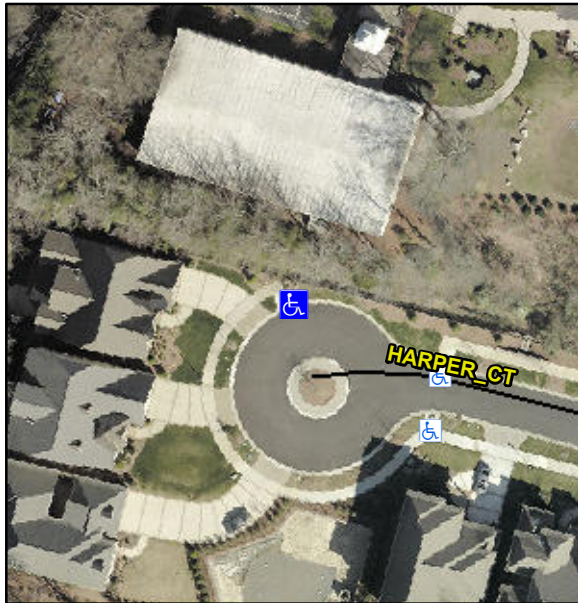
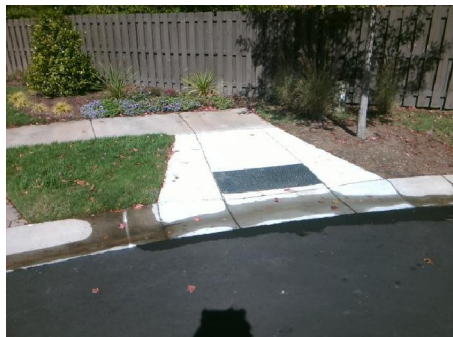
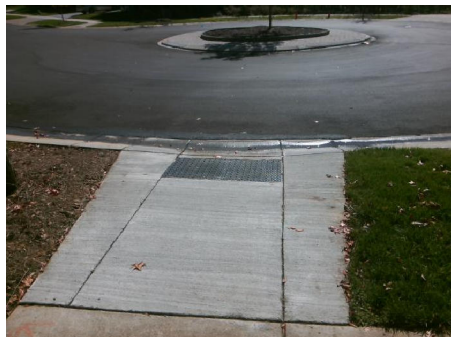
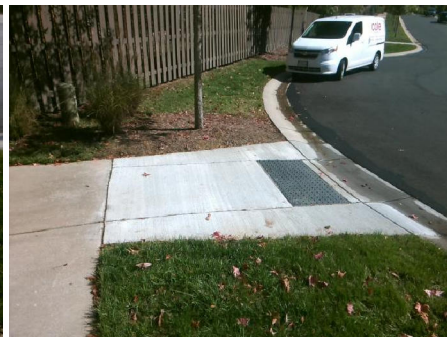
Not Found, R304.5.1, R304.2.2

Possible Solutions:			Compliance	Description	Data	Compliance	Description	Data
Remove & Replace Entire Ramp.			N/A	Ramp Length (in)	96.0	No	Ramp Slope (%)	8.9
			No	Ramp Width (in)	46.0	Yes	Ramp XSlope (%)	1.6
			N/A	Flare Type LT	N/A	N/A	Flare Type RT	N/A
			N/A	Flare Slope LT (%)	N/A	N/A	Flare Slope RT (%)	N/A
			N/A	Flare Traversable LT?	N/A	N/A	Flare Traversable RT?	N/A
			N/A	Landing Length (in)	N/A	N/A	DWS Provided?	N/A
			N/A	Landing Width (in)	N/A	N/A	DWS Contrast?	N/A
			N/A	Landing Slope (%)	N/A	N/A	DWS Length (in)	N/A
			N/A	Landing X Slope (%)	N/A	N/A	DWS Full Width?	N/A
			N/A	Landing Curb? (Y/N)	N/A	N/A	DWS Offset (in)	N/A
			N/A	Shared Landing?	N/A			
			N/A	Gutter Ponding?	N/A	N/A	Gutter Slope (%)	N/A
Surveyor Notes: N/A			N/A	Gutter Lip Ht (in)	N/A	N/A	Gutter X Slope (%)	N/A
			N/A	Painted X Walk1?	No	N/A	Painted X Walk2?	N/A
				X Walk 1 Direction	To S		X Walk 2 Direction	N/A
			N/A	X Walk 1 Width (in)	N/A	N/A	X Walk 2 Width (in)	N/A

X Walk 1 Slope (%)	0.1		X Walk 2 Slope (%)	N/A
				X Walk 1 X Slope (%)	1.8		X Walk 2 X Slope (%)	N/A
			N/A	Ramp inside XWalk1?	N/A	N/A	Ramp inside XWalk2?	N/A
				Road Slope (%)	N/A	N/A	Clear Space?	N/A
				Road X Slope (%)	N/A	N/A	Clear Space to XWalk (in)	N/A
			N/A	Any Obstructions?	N/A	N/A	Storm Grate/Utility Hazard?	N/A
				Obstruction Type			Storm Grate/Utility Type	
					N/A			N/A
Total Cost: \$ 1850.00						Yes	Surface Condition? (G/P)	Good

Possible Solutions:

Remove & Replace Entire Ramp.
