Access Compliance Report

Public Rights-of-Way

(Curb Ramps)

Intersection ID: 43643	Main Street: HUNTINGTON_MEADOW_LN	Cross Street: SOUTHFIELD_DR	Location: NW
ADA ID: CB566306B54C	Ramp Type: PerpDiag	Initial Pass/Fail: Fail	Overall Compliance: No
Severity Score: 10			
Codes/Mitigation Info/Possible Solution		Field Measurements/Component Compliance

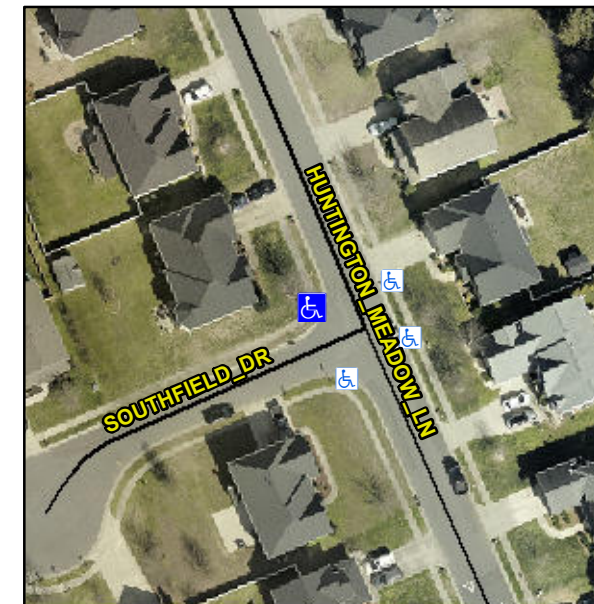
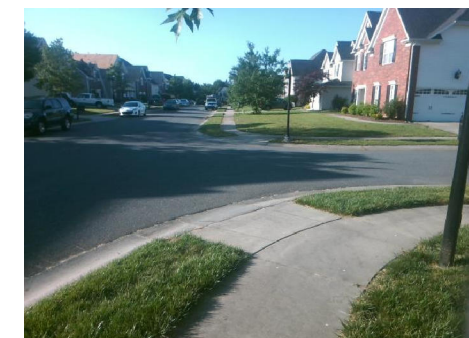
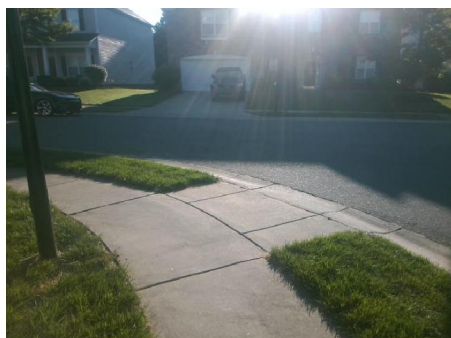
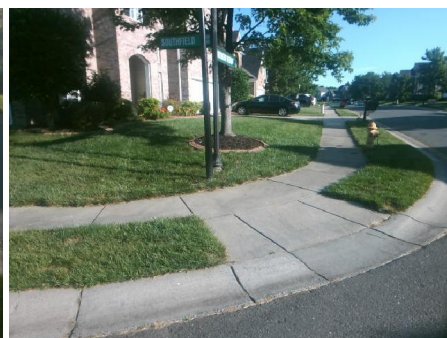
Not Found, R304.5.1, R304.5.3

Compliance	Description	Data	Compliance	Description	Data
N/A	Ramp Length (in)	46.0	Yes	Ramp Slope (%)	7.8
No	Ramp Width (in)	42.0	No	Ramp XSlope (%)	3.2
N/A	Flare Type LT	N/A	N/A	Flare Type RT	N/A
N/A	Flare Slope LT (%)	N/A	N/A	Flare Slope RT (%)	N/A
N/A	Flare Traversable LT?	N/A	N/A	Flare Traversable RT?	N/A
N/A	Landing Length (in)	N/A	N/A	DWS Provided?	N/A
N/A	Landing Width (in)	N/A	N/A	DWS Contrast?	N/A
N/A	Landing Slope (%)	N/A	N/A	DWS Length (in)	N/A
N/A	Landing X Slope (%)	N/A	N/A	DWS Full Width?	N/A
N/A	Landing Curb? (Y/N)	N/A	N/A	DWS Offset (in)	N/A
N/A	Shared Landing?	N/A			
N/A	Gutter Ponding?	N/A	N/A	Gutter Slope (%)	N/A
N/A	Gutter Lip Ht (in)	N/A	N/A	Gutter X Slope (%)	N/A
N/A	Painted X Walk1?	No	N/A	Painted X Walk2?	No
	X Walk 1 Direction	To S		X Walk 2 Direction	To E
N/A	X Walk 1 Width (in)	N/A	N/A	X Walk 2 Width (in)	N/A
	X Walk 1 Slope (%)	0.3		X Walk 2 Slope (%)	1.9
	X Walk 1 X Slope (%)	0.6		X Walk 2 X Slope (%)	1.4

N/A	Ramp inside XWalk1?	N/A	N/A	Ramp inside XWalk2?	N/A
	Road Slope (%)	3.2	N/A	Clear Space?	N/A
	Road X Slope (%)	0.6	N/A	Clear Space to XWalk (in)	N/A
N/A	Any Obstructions?	N/A	N/A	Storm Grate/Utility Hazard?	N/A
	Obstruction Type			Storm Grate/Utility Type	
		N/A			N/A
			Yes	Surface Condition? (G/P)	Good

Remove & Replace Curb Ramp With Two New Directional Ramps or Equivalent.
