Access Compliance Report

Public Rights-of-Way

(Curb Ramps)

Intersection ID: 44080	Main Street: WESTMILL_LN	Cross Street: BRIGHTSTONE_CT	Location: NE
ADA ID: CB5A0131A808	Ramp Type: BlendTrans1	Initial Pass/Fail: Fail	Overall Compliance: No
			Severity Score: 36.25

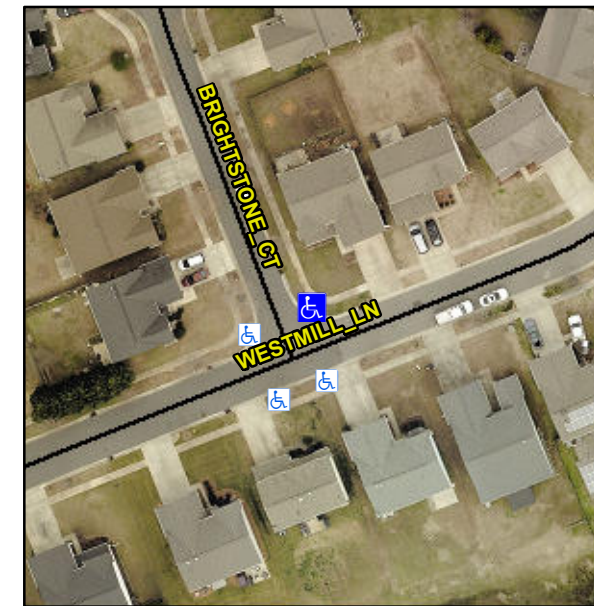
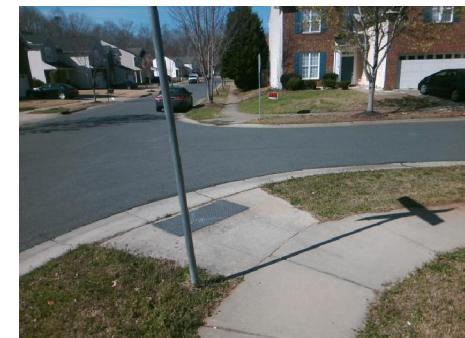
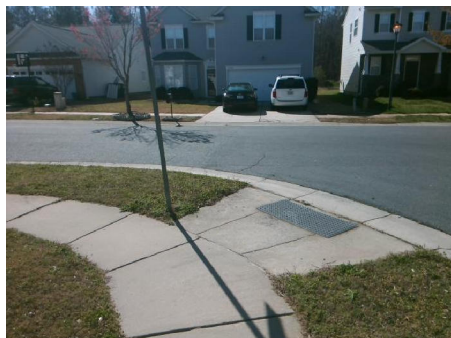
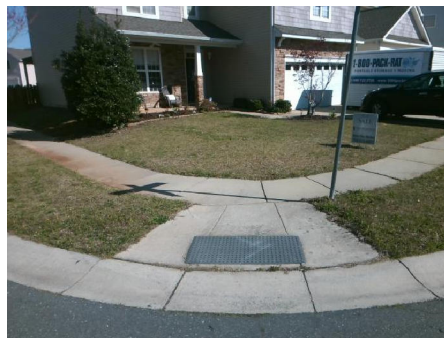
Compliance	Description	Data	Compliance	Description	Data
N/A	Ramp Length (in)	71.0	Yes	BlendTrans Slope (%)	3.3
No	Ramp Width (in)	27.0	No	BlendTrans XSlope (%)	2.2
N/A	Flare Type LT	N/A	N/A	Flare Type RT	N/A
N/A	Flare Slope LT (%)	N/A	N/A	Flare Slope RT (%)	N/A
N/A	Flare Traversable LT?	N/A	N/A	Flare Traversable RT?	N/A
N/A	Landing Length (in)	N/A	N/A	DWS Provided?	N/A
N/A	Landing Width (in)	N/A	N/A	DWS Contrast?	N/A
N/A	Landing Slope (%)	N/A	N/A	DWS Length (in)	N/A
N/A	Landing X Slope (%)	N/A	N/A	DWS Full Width?	N/A
N/A	Landing Curb? (Y/N)	N/A	N/A	DWS Offset (in)	N/A
N/A	Shared Landing?	N/A			
N/A	Gutter Ponding?	N/A	N/A	Gutter Slope (%)	N/A
N/A	Gutter Lip Ht (in)	N/A	N/A	Gutter X Slope (%)	N/A
N/A	Painted X Walk1?	No	N/A	Painted X Walk2?	No
	X Walk 1 Direction	To W		X Walk 2 Direction	To S
	X Walk 1 Width (in)	N/A		X Walk 2 Width (in)	N/A
	X Walk 1 Slope (%)	0.7		X Walk 2 Slope (%)	1.7
	X Walk 1 X Slope (%)	1.0		X Walk 2 X Slope (%)	0.8

N/A	Ramp inside XWalk1?	N/A	N/A	Ramp inside XWalk2?	N/A
	Road Slope (%)	1.9		Clear Space?	N/A
	Road X Slope (%)	1.1	N/A	Clear Space to XWalk (in)	N/A
N/A	Any Obstructions?	N/A	N/A	Storm Grate/Utility Hazard?	N/A
	Obstruction Type			Storm Grate/Utility Type	
		N/A			N/A
			Yes	Surface Condition? (G/P)	Good
			N/A	Curb Slope (%)	0.6

Remove & Replace Curb Ramp With Two New Directional Ramps or Equivalent.

R304.5.1, R304.5.3
