Access Compliance Report Public Rights-of-Way (Curb Ramps)

Intersection ID: 26572 Main Street: ARBORHILL RD **Cross Street: ELIZABETH GLEN DR** Location: ADA ID: CB600D435842 Ramp Type: PerpDiag Initial Pass/Fail: Fail **Overall Compliance: No Severity Score:** 8.75

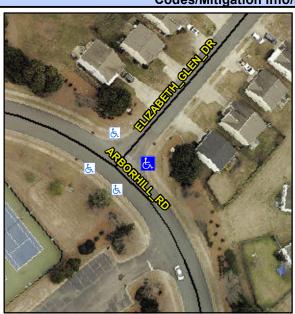
Field Measurements/Component Compliance							
	Comp	Compliance Description		Comp	iance Descripti	ion	Data
	N/A	Ramp Length (in)	49.5	Yes	Ramp Slope (%)	7.3
	No	Ramp Width (in)	38.0	Yes	Ramp XSlope (%)	0.8
	N/A	Flare Type LT	N/A	N/A	Flare Type RT		N/A
	N/A	Flare Slope LT (%)	N/A	N/A	Flare Slope RT	(%)	N/A
	N/A	Flare Traversable LT?	N/A	N/A	Flare Traversab	le RT?	N/A
	N/A	Landing Length (in)	N/A	N/A	DWS Provided?	•	N/A
	N/A	Landing Width (in)	N/A	N/A	DWS Contrast?		N/A
	N/A	Landing Slope (%)	N/A	N/A	DWS Length (in	1)	N/A
	N/A	Landing X Slope (%)	N/A	N/A	DWS Full Width	1?	N/A
	N/A	Landing Curb? (Y/N)	N/A	N/A	DWS Offset (in)	1	N/A
	N/A	Shared Landing?	N/A				
	N/A	Gutter Ponding?	N/A	N/A	Gutter Slope (%	o)	N/A
	N/A	Gutter Lip Ht (in)	N/A	N/A	Gutter X Slope	(%)	N/A
	N/A	Painted X Walk1?	No	N/A	Painted X Walk	2?	No
		X Walk 1 Direction	To NW		X Walk 2 Directi	ion	To SW
	N/A	X Walk 1 Width (in)	N/A	N/A	X Walk 2 Width	(in)	N/A

X Walk 1 Slope (%)	0.7		X Walk 2 Slope	(%)	1.7
		X Walk 1 X Slope (%)	0.6		X Walk 2 X Slop	oe (%)	1.6
	N/A	Ramp inside XWalk1?	N/A	N/A	Ramp inside XV	Valk2?	N/A
		Road Slope (%)	1.7	N/A	Clear Space?		N/A
		Road X Slope (%)	0.4	N/A	Clear Space to	XWalk (in)	N/A
	N/A	Any Obstructions?	N/A	N/A	Storm Grate/Uti	lity Hazard?	N/A
		Obstruction Type			Storm Grate/Uti	lity Type	
			N/A				N/A
				Yes	Surface Condition	on? (G/P)	Good

Possible Solutions: Remove & Replace Curb Ramp With Two New Directional Ramps or Equivalent. Surveyor Notes: N/A PROW/ADA: Not Found, R304.5.1

Total Cost: 3200.00
