# Access Compliance Report

## Public Rights-of-Way

### (Curb Ramps)

Intersection ID: 10041178	Main Street: WEATHERSTONE_CR	Cross Street: N/A	Location: S
ADA ID: CB649D5786C5	Ramp Type: BlendTrans2	Initial Pass/Fail: Fail	Overall Compliance: No
			Severity Score: 33.75

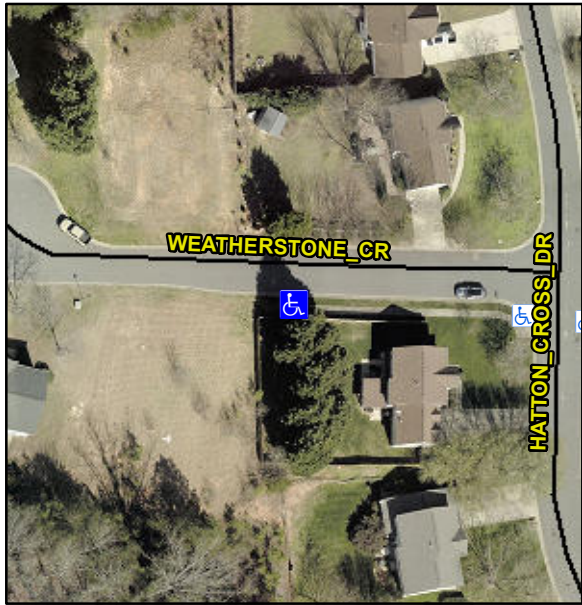
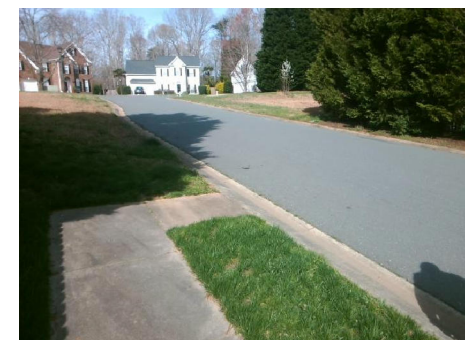
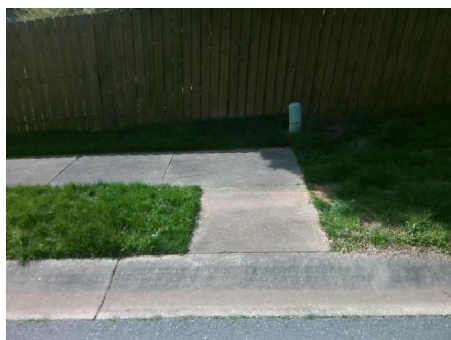
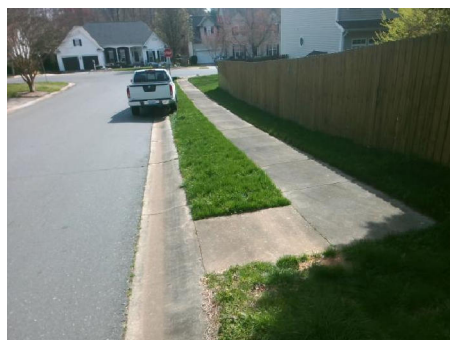
Possible Solutions:		Compliance	Description	Data	Compliance	Description	Data
	Remove & Replace Curb Ramp With Two New Directional Ramps or Equivalent.		N/A	Ramp Length (in)	97.0	Yes	BlendTrans Slope (%)	1.7
			No	Ramp Width (in)	47.5	No	BlendTrans XSlope (%)	11.3
			N/A	Flare Type LT	N/A	N/A	Flare Type RT	N/A
			N/A	Flare Slope LT (%)	N/A	N/A	Flare Slope RT (%)	N/A
			N/A	Flare Traversable LT?	N/A	N/A	Flare Traversable RT?	N/A
			N/A	Landing Length (in)	N/A	N/A	DWS Provided?	N/A
			N/A	Landing Width (in)	N/A	N/A	DWS Contrast?	N/A
			N/A	Landing Slope (%)	N/A	N/A	DWS Length (in)	N/A
			N/A	Landing X Slope (%)	N/A	N/A	DWS Full Width?	N/A
Surveyor Notes:		N/A	N/A	Landing Curb? (Y/N)	N/A	N/A	DWS Offset (in)	N/A
PROW/ADA:		Not Found, R304.5.1, R304.5.3	N/A	Shared Landing?	N/A			
			N/A	Gutter Ponding?	N/A	N/A	Gutter Slope (%)	N/A

N/A	Gutter Lip Ht (in)	N/A	N/A	Gutter X Slope (%)	N/A
			N/A	Painted X Walk1?	No	N/A	Painted X Walk2?	N/A
				X Walk 1 Direction	To N		X Walk 2 Direction	N/A
				X Walk 1 Width (in)	N/A		X Walk 2 Width (in)	N/A
				X Walk 1 Slope (%)	6.2		X Walk 2 Slope (%)	N/A
				X Walk 1 X Slope (%)	10.5		X Walk 2 X Slope (%)	N/A
			N/A	Ramp inside XWalk1?	N/A	N/A	Ramp inside XWalk2?	N/A
				Road Slope (%)	10.5		Clear Space?	N/A
				Road X Slope (%)	6.2	N/A	Clear Space to XWalk (in)	N/A
			N/A	Any Obstructions?	N/A	N/A	Storm Grate/Utility Hazard?	N/A
				Obstruction Type			Storm Grate/Utility Type	
					N/A			N/A
						Yes	Surface Condition? (G/P)	Good
						No	Curb Slope (%)	29.5
