# Access Compliance Report

## Public Rights-of-Way (Curb Ramps)

Intersection ID: 51615	Main Street: BENFIELD_RD	Cross Street: PROSPERITY_CHURCH_RD	Location: SE
ADA ID: CB743AC612FE	Ramp Type: Perp	Initial Pass/Fail: Pass	Overall Compliance: No
Severity Score: 5			
Codes/Mitigation Info/Possible Solution		Field Measurements/Component Compliance

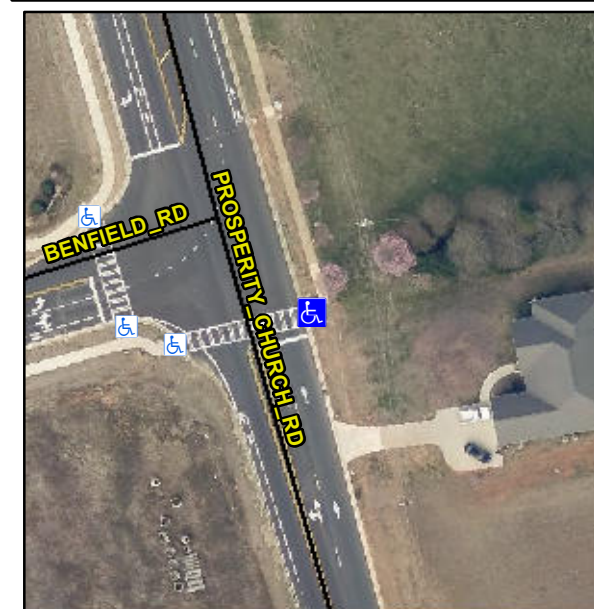
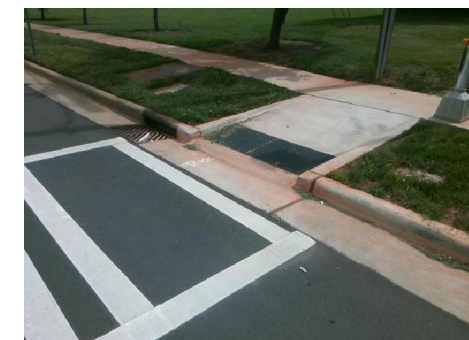
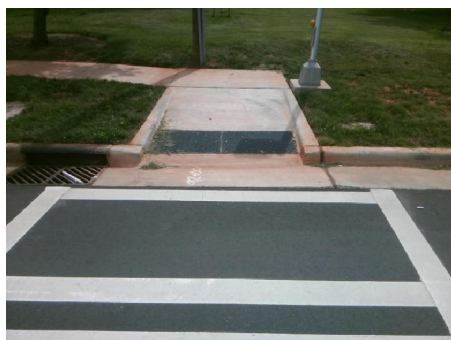
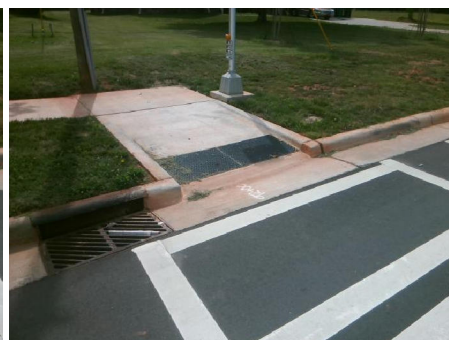
Compliance	Description	Data	Compliance	Description	Data
N/A	Ramp Length (in)	96.0	Yes	Ramp Slope (%)	6.4
Yes	Ramp Width (in)	70.0	Yes	Ramp XSlope (%)	1.6
Yes	Flare Type L	Curbed_NoWalkSurface	Yes	Flare Type RT	N/A
Yes	Flare Slope LT (%)	N/A	N/A	Flare Slope RT (%)	N/A
N/A	Flare Traversable LT?	No	N/A	Flare Traversable RT?	No
Yes	Landing Length (in)	60.0	Yes	DWS Provided?	Yes
Yes	Landing Width (in)	72.0	Yes	DWS Contrast?	Yes
Yes	Landing Slope (%)	0.2	Yes	DWS Length (in)	24.0
Yes	Landing X Slope (%)	1.4	Yes	DWS Full Width?	Yes
N/A	Landing Curb? (Y/N)	No	Yes	DWS Offset (in)	0.0
N/A	Shared Landing?	No			
Yes	Gutter Ponding?	No	No	Gutter Slope (%)	5.6
Yes	Gutter Lip Ht (in)	0.0	No	Gutter X Slope (%)	4.0
N/A	Painted X Walk1?	Yes	N/A	Painted X Walk2?	N/A
	X Walk 1 Direction	To W		X Walk 2 Direction	N/A
N/A	X Walk 1 Width (in)	110.0	N/A	X Walk 2 Width (in)	N/A
	X Walk 1 Slope (%)	1.0		X Walk 2 Slope (%)	N/A
	X Walk 1 X Slope (%)	3.3		X Walk 2 X Slope (%)	N/A

Yes	Ramp inside XWalk1?	Yes	N/A	Ramp inside XWalk2?	N/A
	Road Slope (%)	N/A	N/A	Clear Space?	Yes
	Road X Slope (%)	N/A	N/A	Clear Space to XWalk (in)	N/A
Yes	Any Obstructions?	No	Yes	Storm Grate/Utility Hazard?	No
	Obstruction Type			Storm Grate/Utility Type	
		N/A			N/A
			Yes	Surface Condition? (G/P)	Good

**Remove & Replace Gutter.**

**R304.5.4, R304.5.3**
