# Access Compliance Report

## Public Rights-of-Way

### (Curb Ramps)

Intersection ID: 2799	Main Street: CARDINAL_POINT_RD	Cross Street: RED_ROSE_CT	Location: SW
ADA ID: CB7539BCEC6C	Ramp Type: Perp	Initial Pass/Fail: Fail	Overall Compliance: No
Severity Score: 1.25			
Codes/Mitigation Info/Possible Solution		Field Measurements/Component Compliance

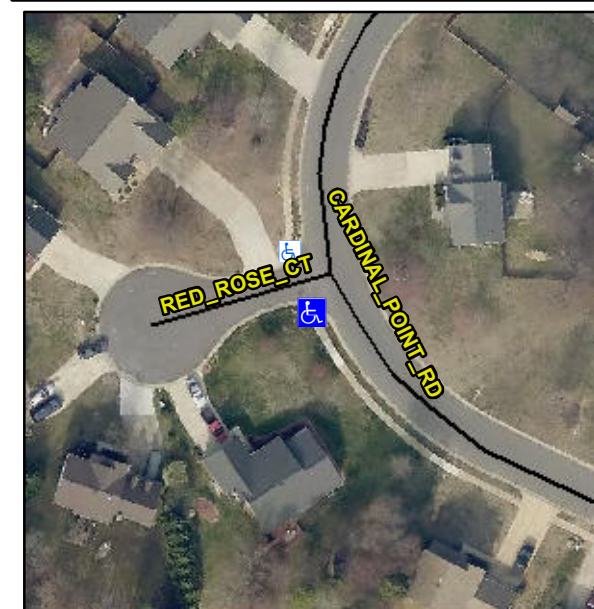
**Not Found, R304.5.3**

Compliance	Description	Data	Compliance	Description	Data
N/A	Ramp Length (in)	32.0	Yes	Ramp Slope (%)	5.6
Yes	Ramp Width (in)	48.0	No	Ramp XSlope (%)	5.0
N/A	Flare Type LT	N/A	N/A	Flare Type RT	N/A
N/A	Flare Slope LT (%)	N/A	N/A	Flare Slope RT (%)	N/A
N/A	Flare Traversable LT?	N/A	N/A	Flare Traversable RT?	N/A
N/A	Landing Length (in)	N/A	N/A	DWS Provided?	N/A
N/A	Landing Width (in)	N/A	N/A	DWS Contrast?	N/A
N/A	Landing Slope (%)	N/A	N/A	DWS Length (in)	N/A
N/A	Landing X Slope (%)	N/A	N/A	DWS Full Width?	N/A
N/A	Landing Curb? (Y/N)	N/A	N/A	DWS Offset (in)	N/A
N/A	Shared Landing?	N/A			
N/A	Gutter Ponding?	N/A	N/A	Gutter Slope (%)	N/A
N/A	Gutter Lip Ht (in)	N/A	N/A	Gutter X Slope (%)	N/A
N/A	Painted X Walk1?	No	N/A	Painted X Walk2?	N/A
	X Walk 1 Direction	To N		X Walk 2 Direction	N/A
N/A	X Walk 1 Width (in)	N/A	N/A	X Walk 2 Width (in)	N/A
	X Walk 1 Slope (%)	0.4		X Walk 2 Slope (%)	N/A
	X Walk 1 X Slope (%)	4.1		X Walk 2 X Slope (%)	N/A

N/A	Ramp inside XWalk1?	N/A	N/A	Ramp inside XWalk2?	N/A
	Road Slope (%)	N/A	N/A	Clear Space?	N/A
	Road X Slope (%)	N/A	N/A	Clear Space to XWalk (in)	N/A
N/A	Any Obstructions?	N/A	N/A	Storm Grate/Utility Hazard?	N/A
	Obstruction Type			Storm Grate/Utility Type	
		N/A			N/A
			Yes	Surface Condition? (G/P)	Good

**Remove & Replace Entire Ramp.**
