Access Compliance Report

Public Rights-of-Way

(Curb Ramps)

Intersection ID: 6233	Main Street: JUNIPER_DR	Cross Street: MILHAVEN_LN	Location: SW
ADA ID: CB7D573EBF91	Ramp Type: Directional1	Initial Pass/Fail: Fail	Overall Compliance: No
		Severity Score: 25

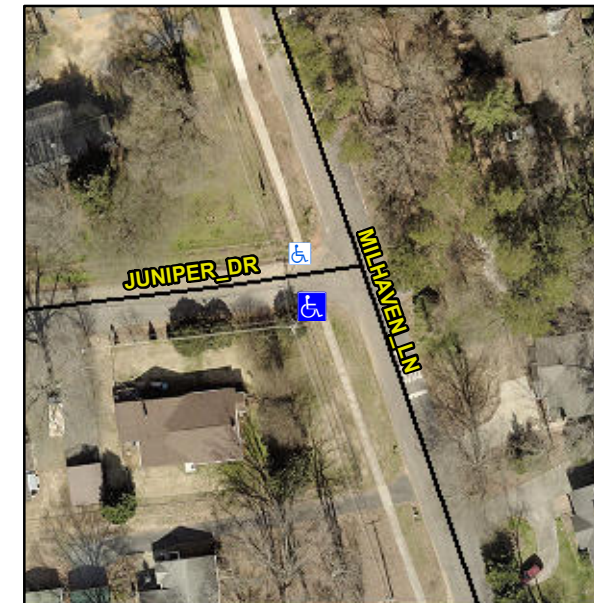
NO CURB

R304.2.2, R304.5.3

Compliance	Description	Data	Compliance	Description	Data
N/A	Ramp Length (in)	26.0	N/A	Grade Break?	N/A
Yes	Ramp Width (in)	60.0	N/A	Grade Break Slope (%)	0.0
No	Ramp Slope (%)	10.0	N/A	Grade Break XSlope (%)	0.0
No	Ramp XSlope (%)	6.5			
N/A	Flare Type LT	N/A	N/A	Flare Type RT	N/A
N/A	Flare Slope LT (%)	N/A	N/A	Flare Slope RT (%)	0.0
N/A	Flare Traversable LT?	N/A	N/A	Flare Traversable RT?	N/A
N/A	Landing Length (in)	0.0	N/A	DWS Provided?	N/A
N/A	Landing Width (in)	0.0	N/A	DWS Contrast?	N/A
N/A	Landing Slope (%)	0.0	N/A	DWS Length (in)	N/A
N/A	Landing X Slope (%)	0.0	N/A	DWS Full Width?	N/A
N/A	Landing Curb? (Y/N)	N/A	N/A	DWS Offset LT (in)	N/A
N/A	Shared Landing?	N/A	N/A	DWS Offset RT (in)	N/A
N/A	Gutter Ponding?	0.0	N/A	Gutter Slope (%)	N/A
N/A	Gutter Lip Ht (in)	0.0	N/A	Gutter X Slope (%)	N/A
N/A	Painted X Walk1?	No		Road Slope (%)	9.2
	X Walk 1 Direction	To N		Road X Slope (%)	6.6
	X Walk 1 Width (in)	N/A		Clear Space?	N/A

X Walk 1 Slope (%)	9.2	N/A	Clear Space to XWalk (in)	N/A
	X Walk 1 X Slope (%)	6.6	N/A	Storm Grate/Utility Hazard?	N/A
N/A	Ramp inside XWalk1?	N/A		Storm Grate/Utility Type	
N/A	Any Obstructions?	N/A			N/A
	Obstruction Type		Yes	Surface Condition? (G/P)	Good
			N/A	Curb Slope (%)	N/A

Remove & Replace Entire Ramp.
