# Access Compliance Report

## Public Rights-of-Way

### (Curb Ramps)

Intersection ID: 11602	Main Street: E_19TH_ST	Cross Street: N_MCDOWELL_ST	Location: E
ADA ID: CB7EADCB3412	Ramp Type: Perp	Initial Pass/Fail: Fail	Overall Compliance: No
		Severity Score: 35

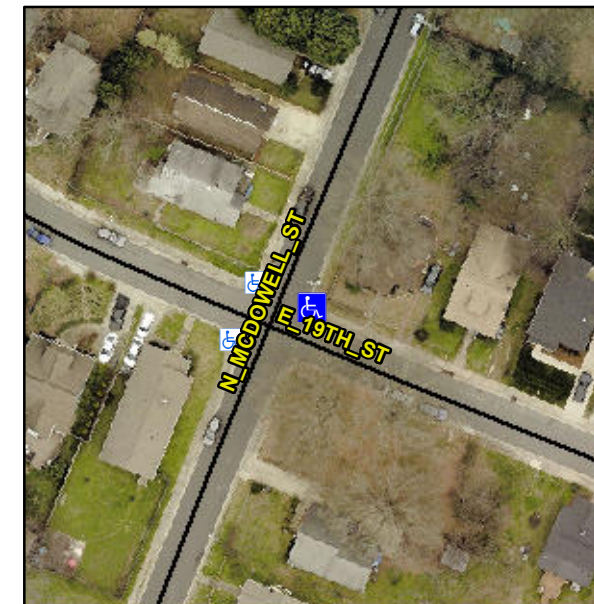
**Not Found, R304.5.1, R304.2.2**

Compliance	Description	Data	Compliance	Description	Data
N/A	Ramp Length (in)	48.0	No	Ramp Slope (%)	12.9
No	Ramp Width (in)	36.0	Yes	Ramp XSlope (%)	4.9
N/A	Flare Type LT	N/A	N/A	Flare Type RT	N/A
N/A	Flare Slope LT (%)	N/A	N/A	Flare Slope RT (%)	N/A
N/A	Flare Traversable LT?	N/A	N/A	Flare Traversable RT?	N/A
N/A	Landing Length (in)	N/A	N/A	DWS Provided?	N/A
N/A	Landing Width (in)	N/A	N/A	DWS Contrast?	N/A
N/A	Landing Slope (%)	N/A	N/A	DWS Length (in)	N/A
N/A	Landing X Slope (%)	N/A	N/A	DWS Full Width?	N/A
N/A	Landing Curb? (Y/N)	N/A	N/A	DWS Offset (in)	N/A
N/A	Shared Landing?	N/A			
N/A	Gutter Ponding?	N/A	N/A	Gutter Slope (%)	N/A
N/A	Gutter Lip Ht (in)	N/A	N/A	Gutter X Slope (%)	N/A
N/A	Painted X Walk1?	No	N/A	Painted X Walk2?	N/A
	X Walk 1 Direction	To NW		X Walk 2 Direction	N/A
N/A	X Walk 1 Width (in)	N/A	N/A	X Walk 2 Width (in)	N/A
	X Walk 1 Slope (%)	3.1		X Walk 2 Slope (%)	N/A
	X Walk 1 X Slope (%)	5.6		X Walk 2 X Slope (%)	N/A

N/A	Ramp inside XWalk1?	N/A	N/A	Ramp inside XWalk2?	N/A
	Road Slope (%)	N/A	N/A	Clear Space?	N/A
	Road X Slope (%)	N/A	N/A	Clear Space to XWalk (in)	N/A
N/A	Any Obstructions?	N/A	N/A	Storm Grate/Utility Hazard?	N/A
	Obstruction Type			Storm Grate/Utility Type	
		N/A			N/A
			Yes	Surface Condition? (G/P)	Good

**Remove & Replace Entire Ramp.**

Total Cost: \$ 1850.00
