Access Compliance Report

Public Rights-of-Way

(Curb Ramps)

Intersection ID: 21887	Main Street: AUTUMN_BLAZE_DR	Cross Street: WITHERS_MILL_DR	Location: E
ADA ID: CB885AB6D8FF	Ramp Type: PerpDiag	Initial Pass/Fail: Fail	Overall Compliance: No
Severity Score: 25			
Codes/Mitigation Info/Possible Solution		Field Measurements/Component Compliance

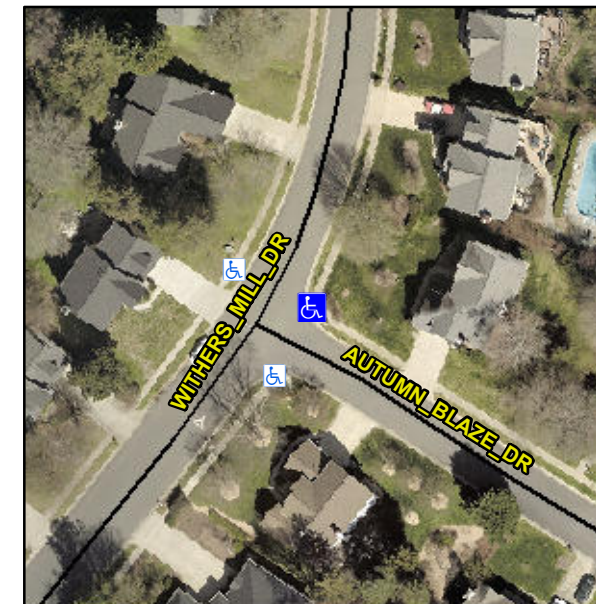
Compliance	Description	Data	Compliance	Description	Data
N/A	Ramp Length (in)	94.0	Yes	Ramp Slope (%)	6.2
Yes	Ramp Width (in)	136.0	No	Ramp XSlope (%)	7.7
N/A	Flare Type LT	N/A	N/A	Flare Type RT	N/A
N/A	Flare Slope LT (%)	N/A	N/A	Flare Slope RT (%)	N/A
N/A	Flare Traversable LT?	N/A	N/A	Flare Traversable RT?	N/A
N/A	Landing Length (in)	N/A	N/A	DWS Provided?	N/A
N/A	Landing Width (in)	N/A	N/A	DWS Contrast?	N/A
N/A	Landing Slope (%)	N/A	N/A	DWS Length (in)	N/A
N/A	Landing X Slope (%)	N/A	N/A	DWS Full Width?	N/A
N/A	Landing Curb? (Y/N)	N/A	N/A	DWS Offset (in)	N/A
N/A	Shared Landing?	N/A			
N/A	Gutter Ponding?	N/A	N/A	Gutter Slope (%)	N/A
N/A	Gutter Lip Ht (in)	N/A	N/A	Gutter X Slope (%)	N/A
N/A	Painted X Walk1?	No	N/A	Painted X Walk2?	No
	X Walk 1 Direction	To NW		X Walk 2 Direction	To SW
N/A	X Walk 1 Width (in)	N/A	N/A	X Walk 2 Width (in)	N/A
	X Walk 1 Slope (%)	4.7		X Walk 2 Slope (%)	0.8
	X Walk 1 X Slope (%)	3.6		X Walk 2 X Slope (%)	5.6

N/A	Ramp inside XWalk1?	N/A	N/A	Ramp inside XWalk2?	N/A
	Road Slope (%)	8.3	N/A	Clear Space?	N/A
	Road X Slope (%)	3.0	N/A	Clear Space to XWalk (in)	N/A
N/A	Any Obstructions?	N/A	N/A	Storm Grate/Utility Hazard?	N/A
	Obstruction Type			Storm Grate/Utility Type	
		N/A			N/A
		Yes		Surface Condition? (G/P)	Good

Possible Solutions:

Remove & Replace Curb Ramp With Two New Directional Ramps or Equivalent.

R304.5.3
