# Access Compliance Report

## Public Rights-of-Way

| Intersection ID: 28385 | Main Street: COMMONS_CROSSING_DR | Cross Street: HIGHLANDS_CROSSING_DR | Location: SE |
| ADA ID: CB9482B68224 | Ramp Type: PerpDiag | Initial Pass/Fail: Pass | Overall Compliance: No |

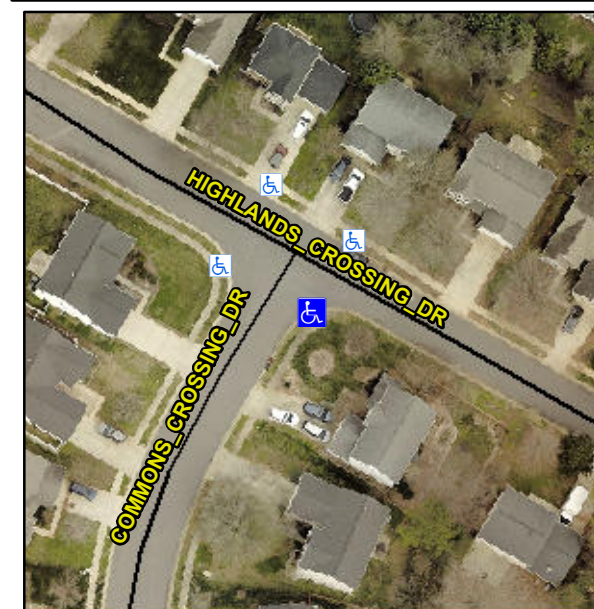
**Not Found, R304.5.3, R305, R304.5.4**

| Compliance | Description | Data | Compliance | Description | Data |
|---|---|---|---|---|---|
| Yes | Ramp Width (in) | 48.0 | No | Ramp XSlope (%) | 3.5 |
| Yes | Landing Length (in) | 48.0 | No | DWS Provided? | No |
| No | Landing X Slope (%) | 3.9 | N/A | DWS Full Width? | No |
| Yes | Gutter Ponding? | No | No | Gutter Slope (%) | 11.7 |

**Remove & Replace Curb Ramp With Two New Directional Ramps or Equivalent. Remove & Replace Gutter.**

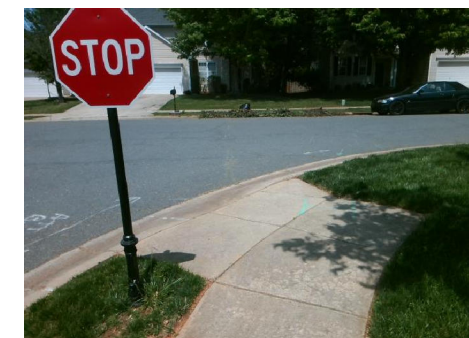
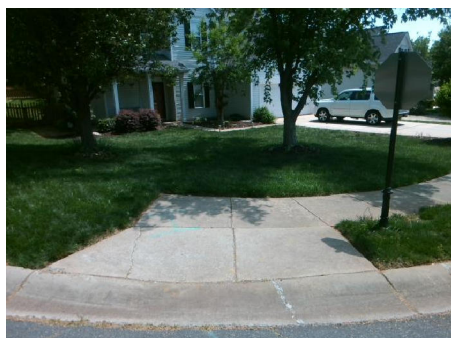
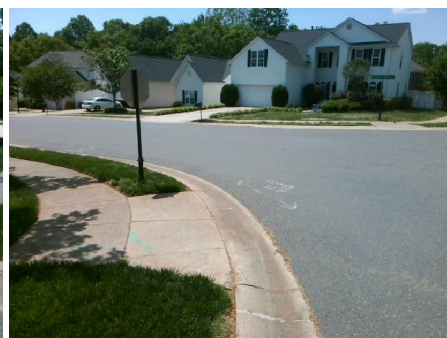
Street 1 Name HIGHLANDS CROSSING DR  
 Stop Condition-Street 2 None  
 Street 2 Name COMMONS CROSSING DR  
 Stop Condition-Street 1 StopSign
