Access Compliance Report

Public Rights-of-Way

(Curb Ramps)

Intersection ID: N/A	Main Street: INDEPENDENCE_RD	Cross Street: N/A	Location: NE
ADA ID: CB9A24ED3111	Ramp Type: PerpDiag	Initial Pass/Fail: Fail	Overall Compliance: No
Severity Score: 13.75			
Codes/Mitigation Info/Possible Solution		Field Measurements/Component Compliance

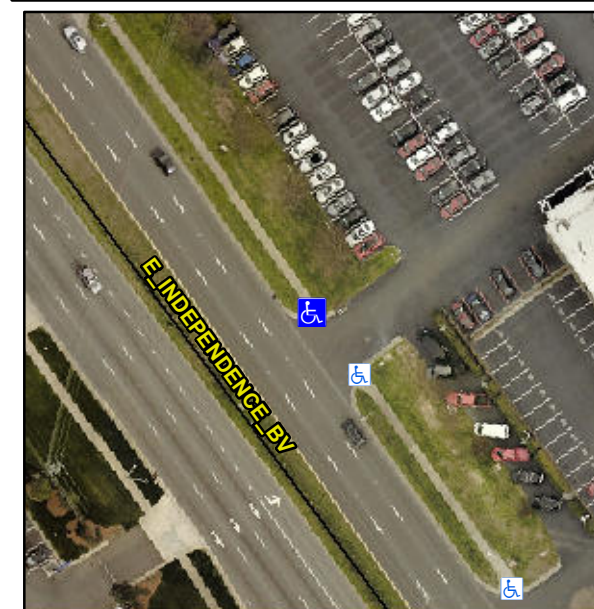
Not Found, R304.2.2

Compliance	Description	Data	Compliance	Description	Data
N/A	Ramp Length (in)	78.0	No	Ramp Slope (%)	11.0
Yes	Ramp Width (in)	48.0	Yes	Ramp XSlope (%)	2.3
N/A	Flare Type LT	N/A	N/A	Flare Type RT	N/A
N/A	Flare Slope LT (%)	N/A	N/A	Flare Slope RT (%)	N/A
N/A	Flare Traversable LT?	N/A	N/A	Flare Traversable RT?	N/A
N/A	Landing Length (in)	N/A	N/A	DWS Provided?	N/A
N/A	Landing Width (in)	N/A	N/A	DWS Contrast?	N/A
N/A	Landing Slope (%)	N/A	N/A	DWS Length (in)	N/A
N/A	Landing X Slope (%)	N/A	N/A	DWS Full Width?	N/A
N/A	Landing Curb? (Y/N)	N/A	N/A	DWS Offset (in)	N/A
N/A	Shared Landing?	N/A			
N/A	Gutter Ponding?	N/A	N/A	Gutter Slope (%)	N/A
N/A	Gutter Lip Ht (in)	N/A	N/A	Gutter X Slope (%)	N/A
N/A	Painted X Walk1?	No	N/A	Painted X Walk2?	No
	X Walk 1 Direction	To W		X Walk 2 Direction	To SE
N/A	X Walk 1 Width (in)	N/A	N/A	X Walk 2 Width (in)	N/A
	X Walk 1 Slope (%)	5.0		X Walk 2 Slope (%)	3.4
	X Walk 1 X Slope (%)	3.7		X Walk 2 X Slope (%)	5.0

N/A	Ramp inside XWalk1?	N/A	N/A	Ramp inside XWalk2?	N/A
	Road Slope (%)	2.4	N/A	Clear Space?	N/A
	Road X Slope (%)	5.0	N/A	Clear Space to XWalk (in)	N/A
N/A	Any Obstructions?	N/A	N/A	Storm Grate/Utility Hazard?	N/A
	Obstruction Type			Storm Grate/Utility Type	
		N/A			N/A
		Yes		Surface Condition? (G/P)	Good

Remove & Replace Curb Ramp With Two New Directional Ramps or Equivalent.
