Access Compliance Report

Public Rights-of-Way

(Curb Ramps)

Intersection ID: 6155	Main Street: OAK_DR	Cross Street: OAKBLUFF_CR	Location: NW
ADA ID: CB9B77801FE7	Ramp Type: BlendTrans1	Initial Pass/Fail: Fail	Overall Compliance: No
Severity Score: 21.25			
Codes/Mitigation Info/Possible Solution		Field Measurements/Component Compliance

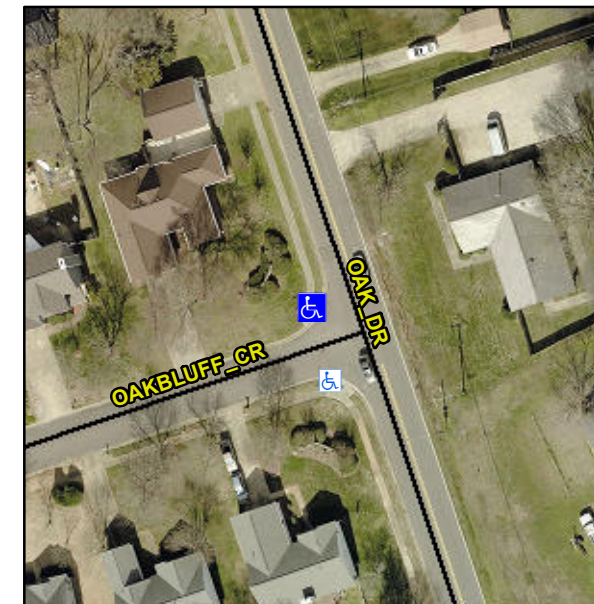
NO LT SW

Not Found, R304.5.1, R304.5.3

Remove & Replace Curb Ramp With Two New Directional Ramps or Equivalent.

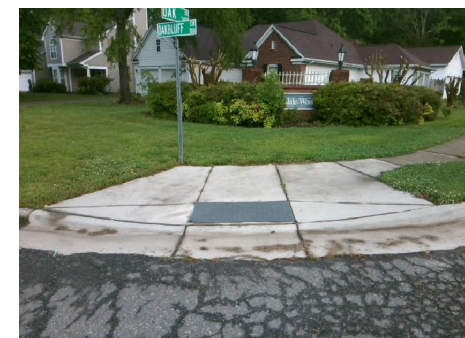
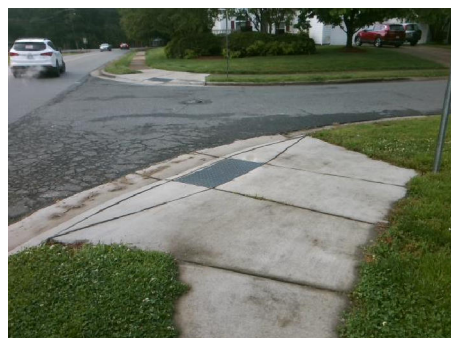
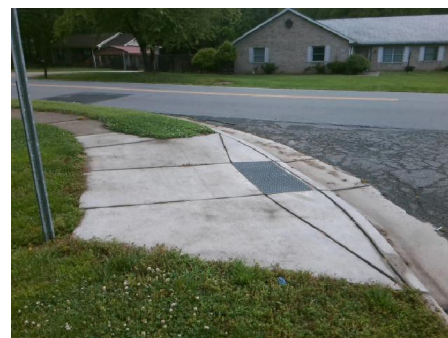
Compliance	Description	Data	Compliance	Description	Data
N/A	Ramp Length (in)	53.0	Yes	BlendTrans Slope (%)	4.6
No	Ramp Width (in)	46.0	No	BlendTrans XSlope (%)	5.7
N/A	Flare Type LT	N/A	N/A	Flare Type RT	N/A
N/A	Flare Slope LT (%)	N/A	N/A	Flare Slope RT (%)	N/A
N/A	Flare Traversable LT?	N/A	N/A	Flare Traversable RT?	N/A
N/A	Landing Length (in)	N/A	N/A	DWS Provided?	N/A
N/A	Landing Width (in)	N/A	N/A	DWS Contrast?	N/A
N/A	Landing Slope (%)	N/A	N/A	DWS Length (in)	N/A
N/A	Landing X Slope (%)	N/A	N/A	DWS Full Width?	N/A
N/A	Landing Curb? (Y/N)	N/A	N/A	DWS Offset (in)	N/A
N/A	Shared Landing?	N/A			
N/A	Gutter Ponding?	N/A	N/A	Gutter Slope (%)	N/A
N/A	Gutter Lip Ht (in)	N/A	N/A	Gutter X Slope (%)	N/A
N/A	Painted X Walk1?	No	N/A	Painted X Walk2?	N/A
	X Walk 1 Direction	To SE		X Walk 2 Direction	N/A
	X Walk 1 Width (in)	N/A		X Walk 2 Width (in)	N/A
	X Walk 1 Slope (%)	3.4		X Walk 2 Slope (%)	N/A
	X Walk 1 X Slope (%)	4.9		X Walk 2 X Slope (%)	N/A

N/A	Ramp inside XWalk1?	N/A	N/A	Ramp inside XWalk2?	N/A
	Road Slope (%)	4.9		Clear Space?	N/A
	Road X Slope (%)	3.4	N/A	Clear Space to XWalk (in)	N/A
N/A	Any Obstructions?	N/A	N/A	Storm Grate/Utility Hazard?	N/A
	Obstruction Type			Storm Grate/Utility Type	
		N/A			N/A
			Yes	Surface Condition? (G/P)	Good
			No	Curb Slope (%)	23.7
