# Access Compliance Report

## Public Rights-of-Way

### (Curb Ramps)

Intersection ID: 4893	Main Street: BAUCOM_RD	Cross Street: HARRINGTON_WOODS_RD	Location: NW
ADA ID: CBA156ED2308	Ramp Type: Perp	Initial Pass/Fail: Fail	Overall Compliance: No
Codes/Mitigation Info/Possible Solution		Field Measurements/Component Compliance

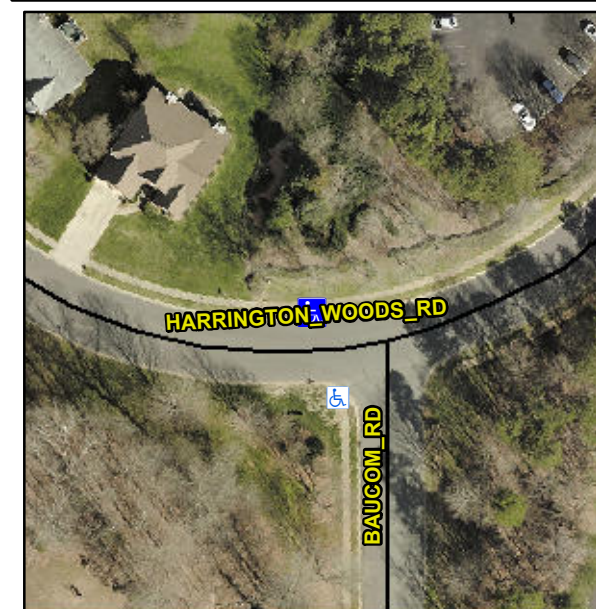
**Not Found, R304.2.2**

Compliance	Description	Data	Compliance	Description	Data
N/A	Ramp Length (in)	47.5	No	Ramp Slope (%)	14.1
Yes	Ramp Width (in)	48.0	Yes	Ramp XSlope (%)	1.6
N/A	Flare Type LT	N/A	N/A	Flare Type RT	N/A
N/A	Flare Slope LT (%)	N/A	N/A	Flare Slope RT (%)	N/A
N/A	Flare Traversable LT?	N/A	N/A	Flare Traversable RT?	N/A
N/A	Landing Length (in)	N/A	N/A	DWS Provided?	N/A
N/A	Landing Width (in)	N/A	N/A	DWS Contrast?	N/A
N/A	Landing Slope (%)	N/A	N/A	DWS Length (in)	N/A
N/A	Landing X Slope (%)	N/A	N/A	DWS Full Width?	N/A
N/A	Landing Curb? (Y/N)	N/A	N/A	DWS Offset (in)	N/A
N/A	Shared Landing?	N/A			
N/A	Gutter Ponding?	N/A	N/A	Gutter Slope (%)	N/A
N/A	Gutter Lip Ht (in)	N/A	N/A	Gutter X Slope (%)	N/A
N/A	Painted X Walk1?	No	N/A	Painted X Walk2?	N/A
	X Walk 1 Direction	To S		X Walk 2 Direction	N/A
N/A	X Walk 1 Width (in)	N/A	N/A	X Walk 2 Width (in)	N/A
	X Walk 1 Slope (%)	2.9		X Walk 2 Slope (%)	N/A
	X Walk 1 X Slope (%)	1.0		X Walk 2 X Slope (%)	N/A

N/A	Ramp inside XWalk1?	N/A	N/A	Ramp inside XWalk2?	N/A
	Road Slope (%)	N/A	N/A	Clear Space?	N/A
	Road X Slope (%)	N/A	N/A	Clear Space to XWalk (in)	N/A
N/A	Any Obstructions?	N/A	N/A	Storm Grate/Utility Hazard?	N/A
	Obstruction Type			Storm Grate/Utility Type	
		N/A			N/A
			Yes	Surface Condition? (G/P)	Good

**Remove & Replace Entire Ramp.**

Total Cost: \$ 1850.00
