Access Compliance Report

Public Rights-of-Way

(Curb Ramps)

Intersection ID: 48373	Main Street: WHEATFIELD_RD	Cross Street: GARDEN_VIEW_DR	Location: NE
ADA ID: CBABB74ED9EC	Ramp Type: PerpDiag	Initial Pass/Fail: Fail	Overall Compliance: No
		Severity Score: 8.75

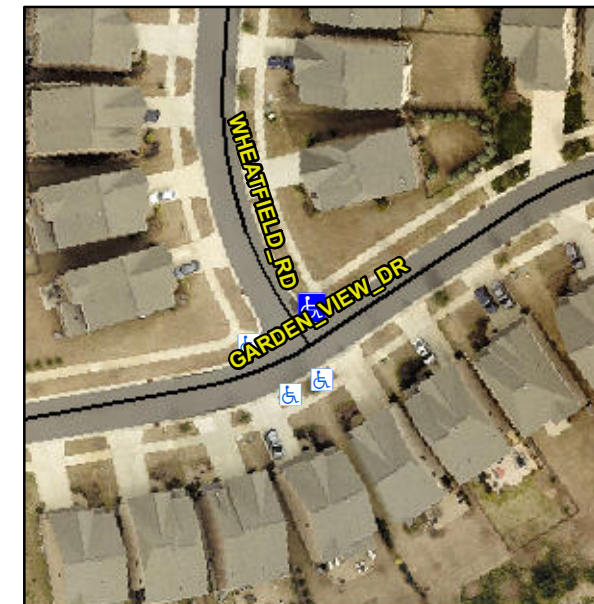
Compliance	Description	Data	Compliance	Description	Data
N/A	Ramp Length (in)	96.0	Yes	Ramp Slope (%)	7.0
No	Ramp Width (in)	47.0	Yes	Ramp XSlope (%)	0.7
N/A	Flare Type LT	N/A	N/A	Flare Type RT	N/A
N/A	Flare Slope LT (%)	N/A	N/A	Flare Slope RT (%)	N/A
N/A	Flare Traversable LT?	N/A	N/A	Flare Traversable RT?	N/A
N/A	Landing Length (in)	N/A	N/A	DWS Provided?	N/A
N/A	Landing Width (in)	N/A	N/A	DWS Contrast?	N/A
N/A	Landing Slope (%)	N/A	N/A	DWS Length (in)	N/A
N/A	Landing X Slope (%)	N/A	N/A	DWS Full Width?	N/A
N/A	Landing Curb? (Y/N)	N/A	N/A	DWS Offset (in)	N/A
N/A	Shared Landing?	N/A			
N/A	Gutter Ponding?	N/A	N/A	Gutter Slope (%)	N/A
N/A	Gutter Lip Ht (in)	N/A	N/A	Gutter X Slope (%)	N/A
N/A	Painted X Walk1?	No	N/A	Painted X Walk2?	No
	X Walk 1 Direction	To SW		X Walk 2 Direction	To SE
N/A	X Walk 1 Width (in)	N/A	N/A	X Walk 2 Width (in)	N/A
	X Walk 1 Slope (%)	0.3		X Walk 2 Slope (%)	1.0
	X Walk 1 X Slope (%)	0.8		X Walk 2 X Slope (%)	1.6

N/A	Ramp inside XWalk1?	N/A	N/A	Ramp inside XWalk2?	N/A
	Road Slope (%)	1.1	N/A	Clear Space?	N/A
	Road X Slope (%)	0.0	N/A	Clear Space to XWalk (in)	N/A
N/A	Any Obstructions?	N/A	N/A	Storm Grate/Utility Hazard?	N/A
	Obstruction Type			Storm Grate/Utility Type	
		N/A			N/A
			Yes	Surface Condition? (G/P)	Good

Possible Solutions:

Remove & Replace Curb Ramp With Two New Directional Ramps or Equivalent.

Not Found, R304.5.1
