Access Compliance Report

Public Rights-of-Way (Curb Ramps)

Intersection ID: 20181	Main Street: ABERDALE_WY	Cross Street: COLLINGHAM_DR	Location: SW
ADA ID: CBABB93AEE7F	Ramp Type: Directional1	Initial Pass/Fail: Fail	Overall Compliance: No
			Severity Score: 21.25

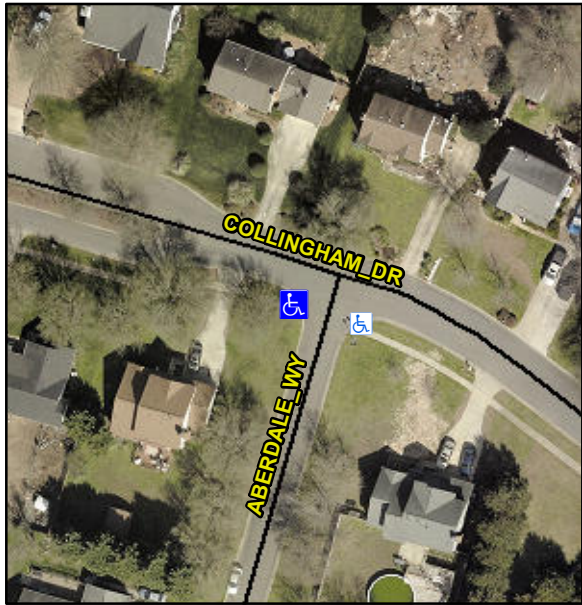
Possible Solutions:		Compliance			Description			Data	
	Remove & Replace Entire Ramp.		N/A	Ramp Length (in)	40.0	N/A	Grade Break?	N/A		
			No	Ramp Width (in)	44.0	N/A	Grade Break Slope (%)	0.0		
			No	Ramp Slope (%)	8.8	N/A	Grade Break XSlope (%)	0.0		
			Yes	Ramp XSlope (%)	0.5					
			N/A	Flare Type LT	N/A	N/A	Flare Type RT	N/A		
			N/A	Flare Slope LT (%)	N/A	N/A	Flare Slope RT (%)	0.0		
			N/A	Flare Traversable LT?	N/A	N/A	Flare Traversable RT?	N/A		
			N/A	Landing Length (in)	0.0	N/A	DWS Provided?	N/A		
			N/A	Landing Width (in)	0.0	N/A	DWS Contrast?	N/A		
		N/A	Landing Slope (%)	0.0	N/A	DWS Length (in)	N/A			
		N/A	Landing X Slope (%)	0.0	N/A	DWS Full Width?	N/A			
		N/A	Landing Curb? (Y/N)	N/A	N/A	DWS Offset LT (in)	N/A			
		N/A	Shared Landing?	N/A	N/A	DWS Offset RT (in)	N/A			
		N/A	Gutter Ponding?	0.0	N/A	Gutter Slope (%)	N/A

N/A	Gutter Lip Ht (in)	0.0	N/A	Gutter X Slope (%)	N/A			
		N/A	Painted X Walk1?	No		Road Slope (%)	2.4			
			X Walk 1 Direction	To E		Road X Slope (%)	5.0			
			X Walk 1 Width (in)	N/A		Clear Space?	N/A			
			X Walk 1 Slope (%)	2.4	N/A	Clear Space to XWalk (in)	N/A			
			X Walk 1 X Slope (%)	5.0	N/A	Storm Grate/Utility Hazard?	N/A			
		N/A	Ramp inside XWalk1?	N/A		Storm Grate/Utility Type				
		N/A	Any Obstructions?	N/A			N/A			
			Obstruction Type		Yes	Surface Condition? (G/P)	Good			
					N/A	Curb Slope (%)	14.6			
			</
