Access Compliance Report

Public Rights-of-Way

(Curb Ramps)

Intersection ID: 28085	Main Street: LANDEN_DR	Cross Street: OLD_CORRAL_ST	Location: NW
ADA ID: CBACDDD99F8C	Ramp Type: PerpDiag	Initial Pass/Fail: Fail	Overall Compliance: No
		Severity Score: 17.5

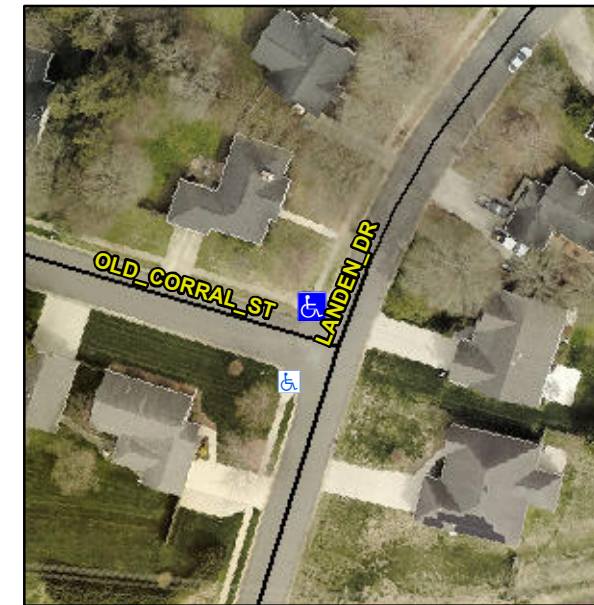
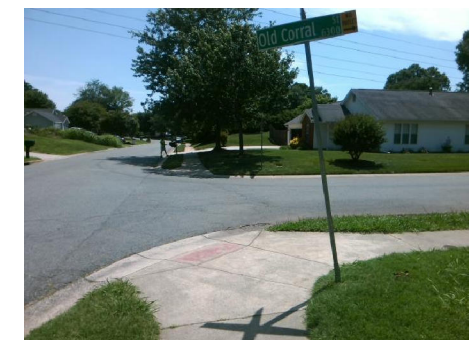
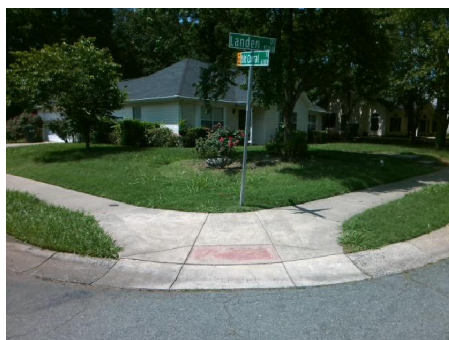
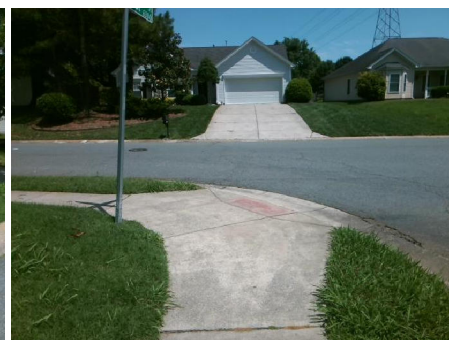
Not Found, R304.5.1

Compliance	Description	Data	Compliance	Description	Data
N/A	Ramp Length (in)	90.0	Yes	Ramp Slope (%)	6.8
No	Ramp Width (in)	35.0	Yes	Ramp XSlope (%)	1.8
N/A	Flare Type LT	N/A	N/A	Flare Type RT	N/A
N/A	Flare Slope LT (%)	N/A	N/A	Flare Slope RT (%)	N/A
N/A	Flare Traversable LT?	N/A	N/A	Flare Traversable RT?	N/A
N/A	Landing Length (in)	N/A	N/A	DWS Provided?	N/A
N/A	Landing Width (in)	N/A	N/A	DWS Contrast?	N/A
N/A	Landing Slope (%)	N/A	N/A	DWS Length (in)	N/A
N/A	Landing X Slope (%)	N/A	N/A	DWS Full Width?	N/A
N/A	Landing Curb? (Y/N)	N/A	N/A	DWS Offset (in)	N/A
N/A	Shared Landing?	N/A			
N/A	Gutter Ponding?	N/A	N/A	Gutter Slope (%)	N/A
N/A	Gutter Lip Ht (in)	0.5	N/A	Gutter X Slope (%)	N/A
N/A	Painted X Walk1?	No	N/A	Painted X Walk2?	No
	X Walk 1 Direction	To SW		X Walk 2 Direction	To SE
N/A	X Walk 1 Width (in)	N/A	N/A	X Walk 2 Width (in)	N/A
	X Walk 1 Slope (%)	1.0		X Walk 2 Slope (%)	4.7
	X Walk 1 X Slope (%)	1.6		X Walk 2 X Slope (%)	0.6

Remove & Replace Curb Ramp With Two New Directional Ramps or Equivalent.
