# Access Compliance Report

## Public Rights-of-Way

### (Curb Ramps)

| Intersection ID: 24411 | Main Street: CAMAROSS_DR | Cross Street: ELPHIN_CT | Location: S |

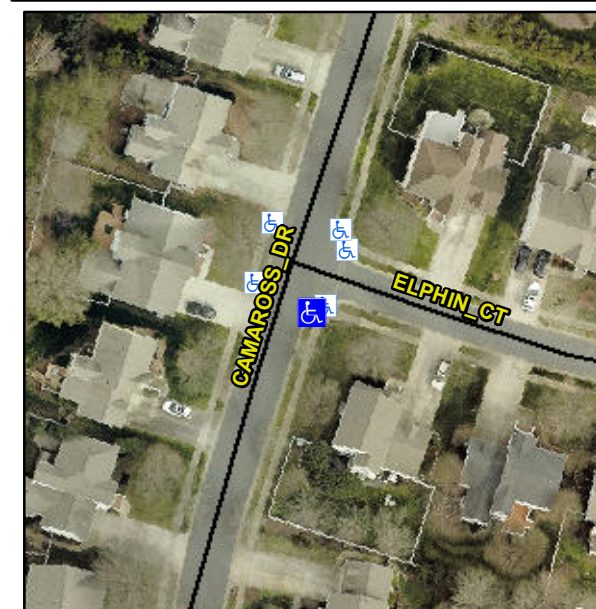
| ADA ID: CBADD234D56E | Ramp Type: Perp | Initial Pass/Fail: Fail | Overall Compliance: No |
| Severity Score: 10 | | | |

**Not Found, R304.5.1, R304.5.3**

| Compliance | Description | Data | Compliance | Description | Data |
|---|---|---|---|---|---|
| N/A | Ramp Length (in) | 47.0 | Yes | Ramp Slope (%) | 5.9 |
| No | Ramp Width (in) | 47.0 | No | Ramp XSlope (%) | 2.3 |

**Remove & Replace Entire Ramp.**

Total Cost: \$ 1850.00
