# Access Compliance Report

## Public Rights-of-Way

### (Curb Ramps)

Intersection ID: 5713	Main Street: RIDGE_ACRES_RD	Cross Street: TRAILING_ROCK_DR	Location: SE
ADA ID: CBB4AE5F44D7	Ramp Type: PerpDiag	Initial Pass/Fail: Fail	Overall Compliance: No
Severity Score: 22.5			
Codes/Mitigation Info/Possible Solution		Field Measurements/Component Compliance

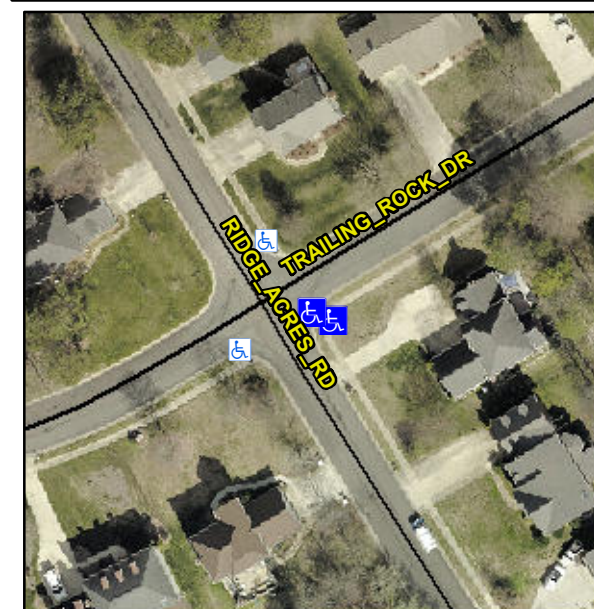
**Not Found, R304.5.1, R304.2.2, R304.5.3**

Compliance	Description	Data	Compliance	Description	Data
N/A	Ramp Length (in)	53.0	No	Ramp Slope (%)	8.8
No	Ramp Width (in)	45.5	No	Ramp XSlope (%)	3.3
N/A	Flare Type LT	N/A	N/A	Flare Type RT	N/A
N/A	Flare Slope LT (%)	N/A	N/A	Flare Slope RT (%)	N/A
N/A	Flare Traversable LT?	N/A	N/A	Flare Traversable RT?	N/A
N/A	Landing Length (in)	N/A	N/A	DWS Provided?	N/A
N/A	Landing Width (in)	N/A	N/A	DWS Contrast?	N/A
N/A	Landing Slope (%)	N/A	N/A	DWS Length (in)	N/A
N/A	Landing X Slope (%)	N/A	N/A	DWS Full Width?	N/A
N/A	Landing Curb? (Y/N)	N/A	N/A	DWS Offset (in)	N/A
N/A	Shared Landing?	N/A			
N/A	Gutter Ponding?	N/A	N/A	Gutter Slope (%)	N/A
N/A	Gutter Lip Ht (in)	N/A	N/A	Gutter X Slope (%)	N/A
N/A	Painted X Walk1?	No	N/A	Painted X Walk2?	No
	X Walk 1 Direction	To N		X Walk 2 Direction	To W
N/A	X Walk 1 Width (in)	N/A	N/A	X Walk 2 Width (in)	N/A
	X Walk 1 Slope (%)	1.3		X Walk 2 Slope (%)	4.5
	X Walk 1 X Slope (%)	2.5		X Walk 2 X Slope (%)	0.2

N/A	Ramp inside XWalk1?	N/A	N/A	Ramp inside XWalk2?	N/A
	Road Slope (%)	3.1	N/A	Clear Space?	N/A
	Road X Slope (%)	2.4	N/A	Clear Space to XWalk (in)	N/A
N/A	Any Obstructions?	N/A	N/A	Storm Grate/Utility Hazard?	N/A
	Obstruction Type			Storm Grate/Utility Type	
		N/A			N/A
			Yes	Surface Condition? (G/P)	Good

**Remove & Replace Curb Ramp With Two New Directional Ramps or Equivalent.**
