# Access Compliance Report

## Public Rights-of-Way

### (Curb Ramps)

| Intersection ID: 10016341 | Main Street: UNIVERSITY_CITY_BV | Cross Street: N/A | Location: NE |

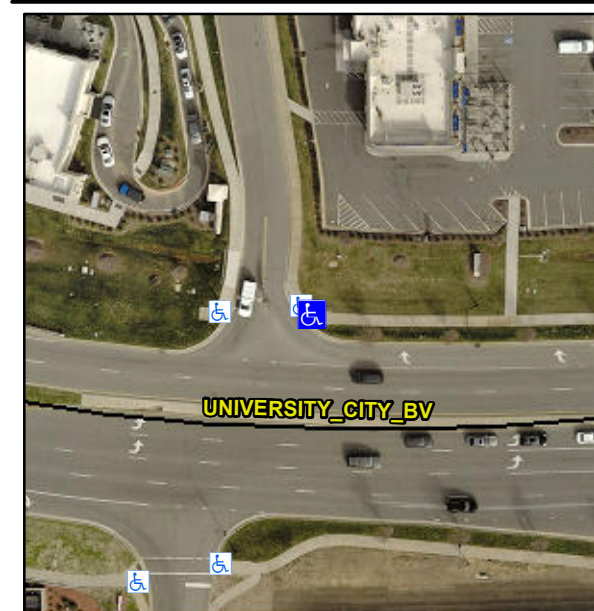
| ADA ID: CBB59C771DED | Ramp Type: Directional1 | Initial Pass/Fail: Fail | Overall Compliance: No |
| Severity Score: 1.25 | | | |

**R304.5.3**

| Compliance | Description | Data | Compliance | Description | Data |
|---|---|---|---|---|---|
| No | Ramp XSlope (%) | 3.1 | | | |

**Remove & Replace Entire Ramp.**

\$ 1600.00
