Access Compliance Report

Public Rights-of-Way

(Curb Ramps)

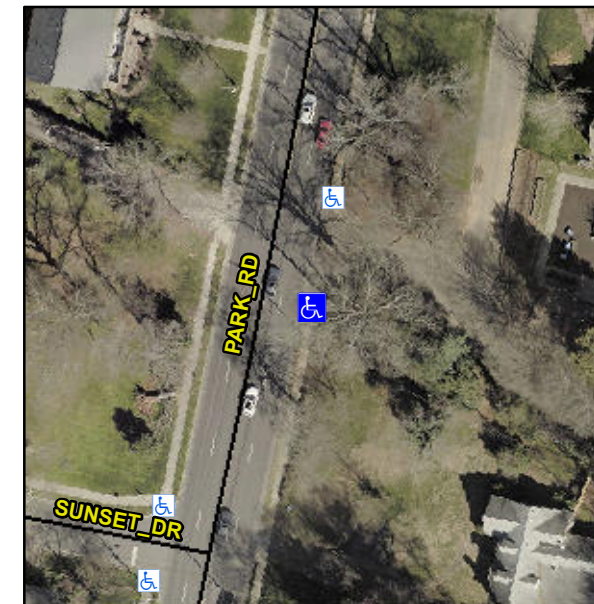
Intersection ID: 10033928	Main Street: PARK_RD	Cross Street: N/A	Location: SE
ADA ID: CBBAFC834EB3	Ramp Type: PerpDiag	Initial Pass/Fail: Fail	Overall Compliance: No
Severity Score: 50			
Codes/Mitigation Info/Possible Solution		Field Measurements/Component Compliance

Compliance	Description	Data	Compliance	Description	Data
N/A	Ramp Length (in)	48.0	No	Ramp Slope (%)	18.0
Yes	Ramp Width (in)	48.0	No	Ramp XSlope (%)	8.5
N/A	Flare Type LT	N/A	N/A	Flare Type RT	N/A
N/A	Flare Slope LT (%)	N/A	N/A	Flare Slope RT (%)	N/A
N/A	Flare Traversable LT?	N/A	N/A	Flare Traversable RT?	N/A
N/A	Landing Length (in)	N/A	N/A	DWS Provided?	N/A
N/A	Landing Width (in)	N/A	N/A	DWS Contrast?	N/A
N/A	Landing Slope (%)	N/A	N/A	DWS Length (in)	N/A
N/A	Landing X Slope (%)	N/A	N/A	DWS Full Width?	N/A
N/A	Landing Curb? (Y/N)	N/A	N/A	DWS Offset (in)	N/A
N/A	Shared Landing?	N/A			
N/A	Gutter Ponding?	N/A	N/A	Gutter Slope (%)	N/A
N/A	Gutter Lip Ht (in)	N/A	N/A	Gutter X Slope (%)	N/A
N/A	Painted X Walk1?	No	N/A	Painted X Walk2?	No
	X Walk 1 Direction	To NE		X Walk 2 Direction	To NW
N/A	X Walk 1 Width (in)	N/A	N/A	X Walk 2 Width (in)	N/A
	X Walk 1 Slope (%)	4.3		X Walk 2 Slope (%)	3.7
	X Walk 1 X Slope (%)	13.7		X Walk 2 X Slope (%)	2.2

N/A	Ramp inside XWalk1?	N/A	N/A	Ramp inside XWalk2?	N/A
	Road Slope (%)	2.2	N/A	Clear Space?	N/A
	Road X Slope (%)	13.3	N/A	Clear Space to XWalk (in)	N/A
N/A	Any Obstructions?	N/A	N/A	Storm Grate/Utility Hazard?	N/A
	Obstruction Type			Storm Grate/Utility Type	
		N/A			N/A
			Yes	Surface Condition? (G/P)	Good

Possible Solutions:

Remove & Replace Curb Ramp With Two New Directional Ramps or Equivalent.

R304.2.2, R304.5.3
