# Access Compliance Report

## Public Rights-of-Way

### (Curb Ramps)

Intersection ID: 13032	Main Street: PROSPECT_ST	Cross Street: CENTRAL_AV	Location: NW
ADA ID: CBC1BF7761BC	Ramp Type: Perp	Initial Pass/Fail: Fail	Overall Compliance: No
Severity Score: 25			
Codes/Mitigation Info/Possible Solution		Field Measurements/Component Compliance

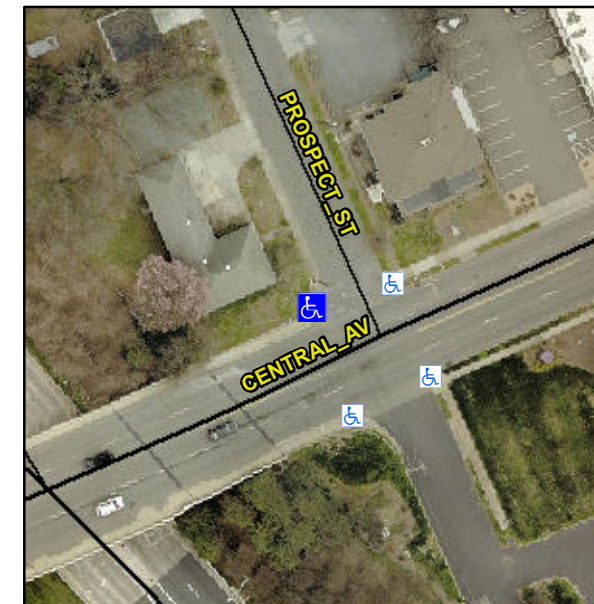
**Not Found, R304.2.2**

Compliance	Description	Data	Compliance	Description	Data
N/A	Ramp Length (in)	49.0	No	Ramp Slope (%)	13.3
Yes	Ramp Width (in)	50.0	Yes	Ramp XSlope (%)	0.5
N/A	Flare Type LT	N/A	N/A	Flare Type RT	N/A
N/A	Flare Slope LT (%)	N/A	N/A	Flare Slope RT (%)	N/A
N/A	Flare Traversable LT?	N/A	N/A	Flare Traversable RT?	N/A
N/A	Landing Length (in)	N/A	N/A	DWS Provided?	N/A
N/A	Landing Width (in)	N/A	N/A	DWS Contrast?	N/A
N/A	Landing Slope (%)	N/A	N/A	DWS Length (in)	N/A
N/A	Landing X Slope (%)	N/A	N/A	DWS Full Width?	N/A
N/A	Landing Curb? (Y/N)	N/A	N/A	DWS Offset (in)	N/A
N/A	Shared Landing?	N/A			
N/A	Gutter Ponding?	N/A	N/A	Gutter Slope (%)	N/A
N/A	Gutter Lip Ht (in)	N/A	N/A	Gutter X Slope (%)	N/A
N/A	Painted X Walk1?	No	N/A	Painted X Walk2?	N/A
	X Walk 1 Direction	To E		X Walk 2 Direction	N/A
N/A	X Walk 1 Width (in)	N/A	N/A	X Walk 2 Width (in)	N/A
	X Walk 1 Slope (%)	5.0		X Walk 2 Slope (%)	N/A
	X Walk 1 X Slope (%)	1.7		X Walk 2 X Slope (%)	N/A

N/A	Ramp inside XWalk1?	N/A	N/A	Ramp inside XWalk2?	N/A
	Road Slope (%)	N/A	N/A	Clear Space?	N/A
	Road X Slope (%)	N/A	N/A	Clear Space to XWalk (in)	N/A
N/A	Any Obstructions?	N/A	N/A	Storm Grate/Utility Hazard?	N/A
	Obstruction Type			Storm Grate/Utility Type	
		N/A			N/A
			Yes	Surface Condition? (G/P)	Good

**Remove & Replace Entire Ramp.**

Total Cost: \$ 1850.00
