Access Compliance Report

Public Rights-of-Way

(Curb Ramps)

Intersection ID: 11512	Main Street: N_SMITH_ST	Cross Street: W_7TH_ST	Location: E
ADA ID: CBC6D9D333E8	Ramp Type: PerpDiag	Initial Pass/Fail: Fail	Overall Compliance: No
		Severity Score: 37.5

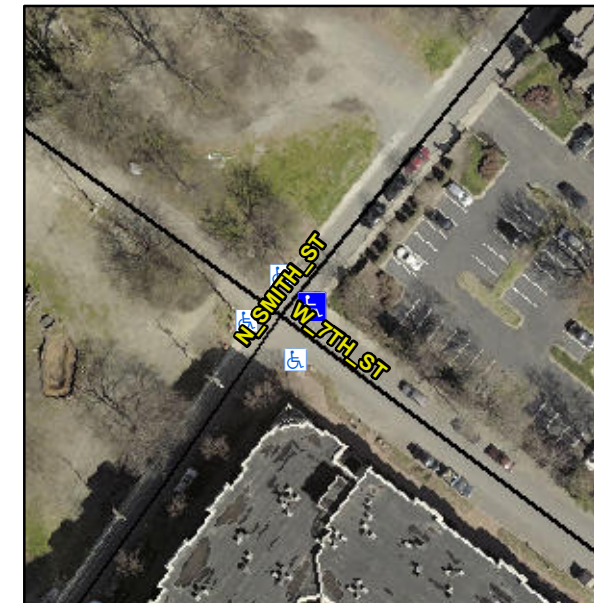
Not Found, R304.5.1, R304.2.2, R304.5.3, R302.7

Compliance	Description	Data	Compliance	Description	Data
N/A	Ramp Length (in)	62.0	No	Ramp Slope (%)	8.5
No	Ramp Width (in)	36.0	No	Ramp XSlope (%)	3.9
N/A	Flare Type LT	N/A	N/A	Flare Type RT	N/A
N/A	Flare Slope LT (%)	N/A	N/A	Flare Slope RT (%)	N/A
N/A	Flare Traversable LT?	N/A	N/A	Flare Traversable RT?	N/A
N/A	Landing Length (in)	N/A	N/A	DWS Provided?	N/A
N/A	Landing Width (in)	N/A	N/A	DWS Contrast?	N/A
N/A	Landing Slope (%)	N/A	N/A	DWS Length (in)	N/A
N/A	Landing X Slope (%)	N/A	N/A	DWS Full Width?	N/A
N/A	Landing Curb? (Y/N)	N/A	N/A	DWS Offset (in)	N/A
N/A	Shared Landing?	N/A			
N/A	Gutter Ponding?	N/A	N/A	Gutter Slope (%)	N/A
N/A	Gutter Lip Ht (in)	N/A	N/A	Gutter X Slope (%)	N/A
N/A	Painted X Walk1?	No	N/A	Painted X Walk2?	No
	X Walk 1 Direction	To NW		X Walk 2 Direction	To SW
N/A	X Walk 1 Width (in)	N/A	N/A	X Walk 2 Width (in)	N/A
	X Walk 1 Slope (%)	6.8		X Walk 2 Slope (%)	3.8
	X Walk 1 X Slope (%)	0.1		X Walk 2 X Slope (%)	2.3

N/A	Ramp inside XWalk1?	N/A	N/A	Ramp inside XWalk2?	N/A
	Road Slope (%)	7.9	N/A	Clear Space?	N/A
	Road X Slope (%)	3.9	N/A	Clear Space to XWalk (in)	N/A
N/A	Any Obstructions?	N/A	N/A	Storm Grate/Utility Hazard?	N/A
	Obstruction Type			Storm Grate/Utility Type	
		N/A			N/A
		No		Surface Condition? (G/P)	Poor

Remove & Replace Curb Ramp With Two New Directional Ramps or Equivalent.
