Access Compliance Report

Public Rights-of-Way

(Curb Ramps)

Intersection ID: 19937	Main Street: S_TRYON_ST	Cross Street: THORNFIELD_RD	Location: SE
ADA ID: CBCC977E417F	Ramp Type: PerpDiag	Initial Pass/Fail: Pass	Overall Compliance: No
Severity Score: 0			
Codes/Mitigation Info/Possible Solution		Field Measurements/Component Compliance

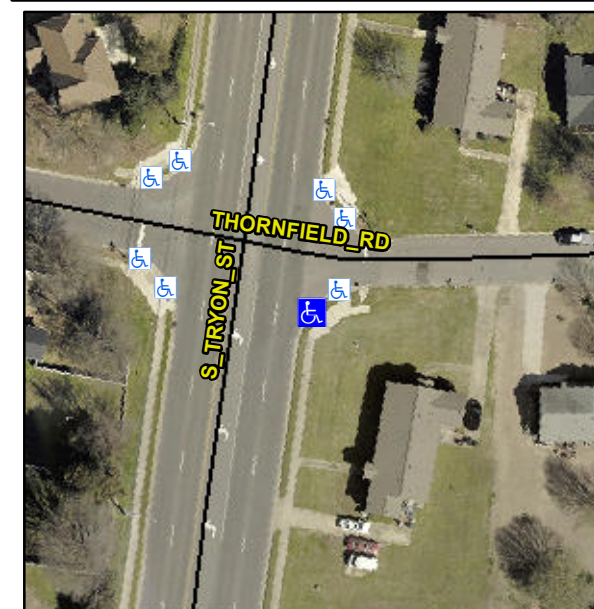
Compliance	Description	Data	Compliance	Description	Data
N/A	Ramp Length (in)	97.5	Yes	Ramp Slope (%)	7.7
Yes	Ramp Width (in)	60.0	Yes	Ramp XSlope (%)	0.7
N/A	Flare Type LT	Sloped	N/A	Flare Type RT	N/A
N/A	Flare Slope LT (%)	10.1	N/A	Flare Slope RT (%)	6.3
N/A	Flare Traversable LT?	No	N/A	Flare Traversable RT?	No
Yes	Landing Length (in)	48.0	Yes	DWS Provided?	Yes
Yes	Landing Width (in)	60.0	Yes	DWS Contrast?	Yes
Yes	Landing Slope (%)	0.7	Yes	DWS Length (in)	24.0
Yes	Landing X Slope (%)	0.8	Yes	DWS Full Width?	Yes
N/A	Landing Curb? (Y/N)	No	No	DWS Offset (in)	3.5
N/A	Shared Landing?	No			
Yes	Gutter Ponding?	No	Yes	Gutter Slope (%)	1.9
Yes	Gutter Lip Ht (in)	0.0	Yes	Gutter X Slope (%)	1.1
N/A	Painted X Walk1?	No	N/A	Painted X Walk2?	No
	X Walk 1 Direction	To N		X Walk 2 Direction	To W
N/A	X Walk 1 Width (in)	N/A	N/A	X Walk 2 Width (in)	N/A
	X Walk 1 Slope (%)	5.4		X Walk 2 Slope (%)	7.5
	X Walk 1 X Slope (%)	5.8		X Walk 2 X Slope (%)	2.3

N/A	Ramp inside XWalk1?	N/A	N/A	Ramp inside XWalk2?	N/A
	Road Slope (%)	1.7	N/A	Clear Space?	Yes
	Road X Slope (%)	10.2	N/A	Clear Space to XWalk (in)	N/A
Yes	Any Obstructions?	No	Yes	Storm Grate/Utility Hazard?	No
	Obstruction Type			Storm Grate/Utility Type	
		N/A			N/A
			Yes	Surface Condition? (G/P)	Good

Possible Solutions:

Remove & Replace Detectable Warning System.

R305.2

\$ 800.00
