Access Compliance Report

Public Rights-of-Way

(Curb Ramps)

Intersection ID: 13404	Main Street: LEXINGTON_AV	Cross Street: E_CARSON_BV	Location:	N
ADA ID: CBD26B61B429	Ramp Type: BlendTrans1	Initial Pass/Fail: Fail	Overall Compliance: No	Severity Score: 8.75
Codes/Mitigation Info/Possible Solution		Field Measurements/Component Compliance

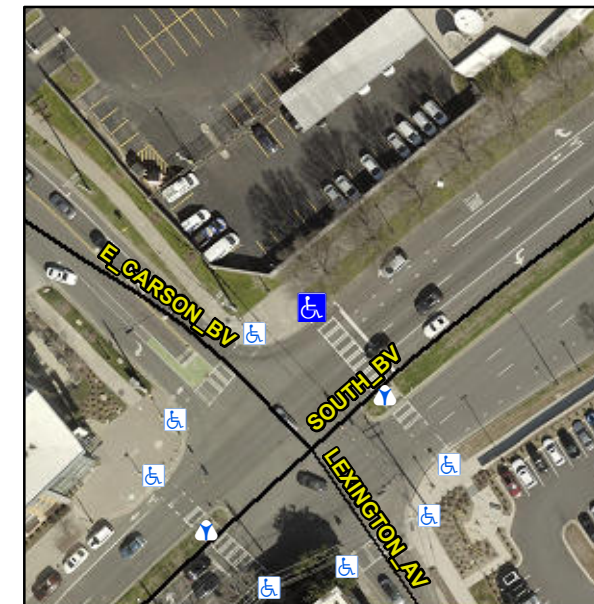
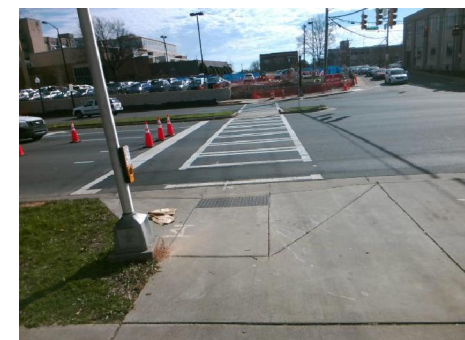
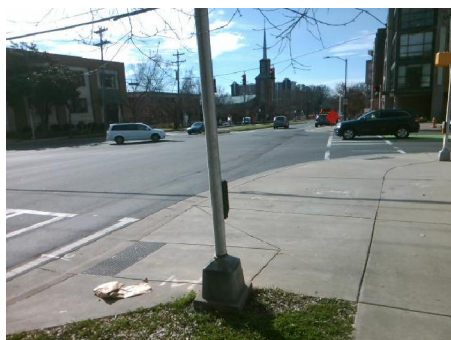
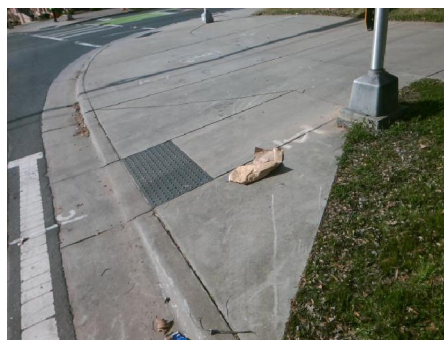
Not Found, R304.5.1

Compliance	Description	Data	Compliance	Description	Data
N/A	Ramp Length (in)	96.0	Yes	BlendTrans Slope (%)	4.3
No	Ramp Width (in)	45.0	Yes	BlendTrans XSlope (%)	1.6
N/A	Flare Type LT	N/A	N/A	Flare Type RT	N/A
N/A	Flare Slope LT (%)	N/A	N/A	Flare Slope RT (%)	N/A
N/A	Flare Traversable LT?	N/A	N/A	Flare Traversable RT?	N/A
N/A	Landing Length (in)	N/A	N/A	DWS Provided?	N/A
N/A	Landing Width (in)	N/A	N/A	DWS Contrast?	N/A
N/A	Landing Slope (%)	N/A	N/A	DWS Length (in)	N/A
N/A	Landing X Slope (%)	N/A	N/A	DWS Full Width?	N/A
N/A	Landing Curb? (Y/N)	N/A	N/A	DWS Offset (in)	N/A
N/A	Shared Landing?	N/A			
N/A	Gutter Ponding?	N/A	N/A	Gutter Slope (%)	N/A
N/A	Gutter Lip Ht (in)	N/A	N/A	Gutter X Slope (%)	N/A
N/A	Painted X Walk1?	Yes	N/A	Painted X Walk2?	N/A
	X Walk 1 Direction	To SE		X Walk 2 Direction	N/A
	X Walk 1 Width (in)	112.0		X Walk 2 Width (in)	N/A
	X Walk 1 Slope (%)	4.5		X Walk 2 Slope (%)	N/A
	X Walk 1 X Slope (%)	1.3		X Walk 2 X Slope (%)	N/A

N/A	Ramp inside XWalk1?	Yes	N/A	Ramp inside XWalk2?	N/A
	Road Slope (%)	1.3		Clear Space?	N/A
	Road X Slope (%)	4.5	N/A	Clear Space to XWalk (in)	N/A
N/A	Any Obstructions?	N/A	N/A	Storm Grate/Utility Hazard?	N/A
	Obstruction Type			Storm Grate/Utility Type	
		N/A			N/A
			Yes	Surface Condition? (G/P)	Good
			No	Curb Slope (%)	8.8

Remove & Replace Curb Ramp With Two New Directional Ramps or Equivalent.

Total Cost: \$ 3200.00
