Access Compliance Report

Public Rights-of-Way

(Curb Ramps)

Intersection ID: 28305	Main Street: COMMUNITY HOUSE RD	Cross Street: TAMARRON DR	Location: SW
ADA ID: CBD4775B2815	Ramp Type: Perp	Initial Pass/Fail: Fail	Overall Compliance: No
Codes/Mitigation Info/Possible Solution		Field Measurements/Component Compliance

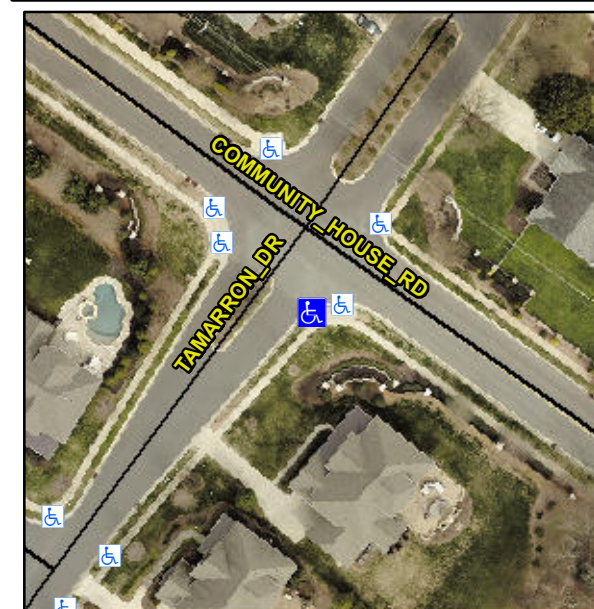
Not Found, R304.5.1, R304.2.2, R304.5.3

Compliance	Description	Data	Compliance	Description	Data
N/A	Ramp Length (in)	51.0	No	Ramp Slope (%)	9.5
No	Ramp Width (in)	47.0	No	Ramp XSlope (%)	5.1
N/A	Flare Type LT	N/A	N/A	Flare Type RT	N/A
N/A	Flare Slope LT (%)	N/A	N/A	Flare Slope RT (%)	N/A
N/A	Flare Traversable LT?	N/A	N/A	Flare Traversable RT?	N/A
N/A	Landing Length (in)	N/A	N/A	DWS Provided?	N/A
N/A	Landing Width (in)	N/A	N/A	DWS Contrast?	N/A
N/A	Landing Slope (%)	N/A	N/A	DWS Length (in)	N/A
N/A	Landing X Slope (%)	N/A	N/A	DWS Full Width?	N/A
N/A	Landing Curb? (Y/N)	N/A	N/A	DWS Offset (in)	N/A
N/A	Shared Landing?	N/A			
N/A	Gutter Ponding?	N/A	N/A	Gutter Slope (%)	N/A
N/A	Gutter Lip Ht (in)	N/A	N/A	Gutter X Slope (%)	N/A
N/A	Painted X Walk1?	No	N/A	Painted X Walk2?	N/A
	X Walk 1 Direction	To NW		X Walk 2 Direction	N/A
N/A	X Walk 1 Width (in)	N/A	N/A	X Walk 2 Width (in)	N/A
	X Walk 1 Slope (%)	2.9		X Walk 2 Slope (%)	N/A
	X Walk 1 X Slope (%)	6.0		X Walk 2 X Slope (%)	N/A

N/A	Ramp inside XWalk1?	N/A	N/A	Ramp inside XWalk2?	N/A
	Road Slope (%)	N/A	N/A	Clear Space?	N/A
	Road X Slope (%)	N/A	N/A	Clear Space to XWalk (in)	N/A
N/A	Any Obstructions?	N/A	N/A	Storm Grate/Utility Hazard?	N/A
	Obstruction Type			Storm Grate/Utility Type	
		N/A			N/A
			Yes	Surface Condition? (G/P)	Good

Possible Solutions:

Remove & Replace Entire Ramp.

Total Cost: \$ 1850.00
