# Access Compliance Report

## Public Rights-of-Way

### (Curb Ramps)

Intersection ID: 10035790	Main Street: REMOUNT_RD	Cross Street: N/A	Location:	N
ADA ID: CBD9F9BC1780	Ramp Type: Perp	Initial Pass/Fail: Fail	Overall Compliance: No	Severity Score: 13.75
Codes/Mitigation Info/Possible Solution		Field Measurements/Component Compliance

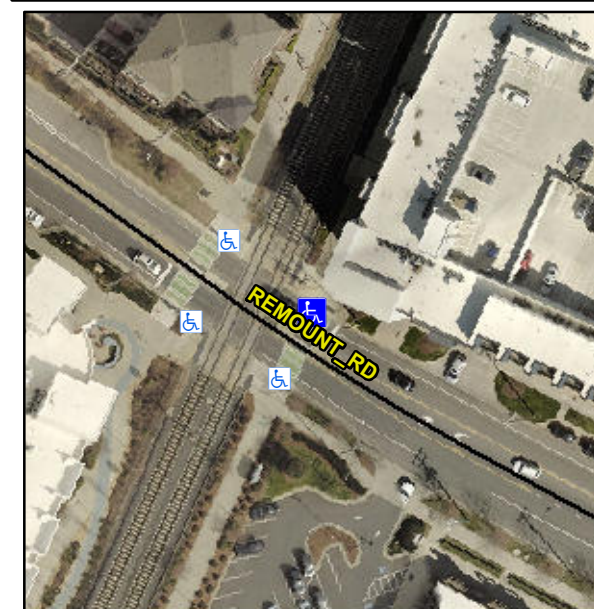
Compliance	Description	Data	Compliance	Description	Data
N/A	Ramp Length (in)	103.0	No	Ramp Slope (%)	8.6
Yes	Ramp Width (in)	144.0	Yes	Ramp XSlope (%)	2.8
N/A	Flare Type LT	N/A	N/A	Flare Type RT	N/A
N/A	Flare Slope LT (%)	N/A	N/A	Flare Slope RT (%)	N/A
N/A	Flare Traversable LT?	N/A	N/A	Flare Traversable RT?	N/A
N/A	Landing Length (in)	N/A	N/A	DWS Provided?	N/A
N/A	Landing Width (in)	N/A	N/A	DWS Contrast?	N/A
N/A	Landing Slope (%)	N/A	N/A	DWS Length (in)	N/A
N/A	Landing X Slope (%)	N/A	N/A	DWS Full Width?	N/A
N/A	Landing Curb? (Y/N)	N/A	N/A	DWS Offset (in)	N/A
N/A	Shared Landing?	N/A			
N/A	Gutter Ponding?	N/A	N/A	Gutter Slope (%)	N/A
N/A	Gutter Lip Ht (in)	N/A	N/A	Gutter X Slope (%)	N/A
N/A	Painted X Walk1?	Yes	N/A	Painted X Walk2?	N/A
	X Walk 1 Direction	To SW		X Walk 2 Direction	N/A
N/A	X Walk 1 Width (in)	136.0	N/A	X Walk 2 Width (in)	N/A
	X Walk 1 Slope (%)	0.5		X Walk 2 Slope (%)	N/A
	X Walk 1 X Slope (%)	3.1		X Walk 2 X Slope (%)	N/A

N/A	Ramp inside XWalk1?	Yes	N/A	Ramp inside XWalk2?	N/A
	Road Slope (%)	N/A	N/A	Clear Space?	N/A
	Road X Slope (%)	N/A	N/A	Clear Space to XWalk (in)	N/A
N/A	Any Obstructions?	N/A	N/A	Storm Grate/Utility Hazard?	N/A
	Obstruction Type			Storm Grate/Utility Type	
		N/A			N/A
			Yes	Surface Condition? (G/P)	Good

Possible Solutions:

**Remove & Replace Entire Ramp.**

**R304.2.2**

\$ 1850.00
