# Access Compliance Report

## Public Rights-of-Way

### (Curb Ramps)

Intersection ID: 4999	Main Street: E_MALLARD_CREEK_CHURCH_RD	Cross Street: STONE_QUARRY_RD	Location: S
ADA ID: CBDDC4B57F45	Ramp Type: Perp	Initial Pass/Fail: Fail	Overall Compliance: No
Severity Score: 22.5			
Codes/Mitigation Info/Possible Solution		Field Measurements/Component Compliance

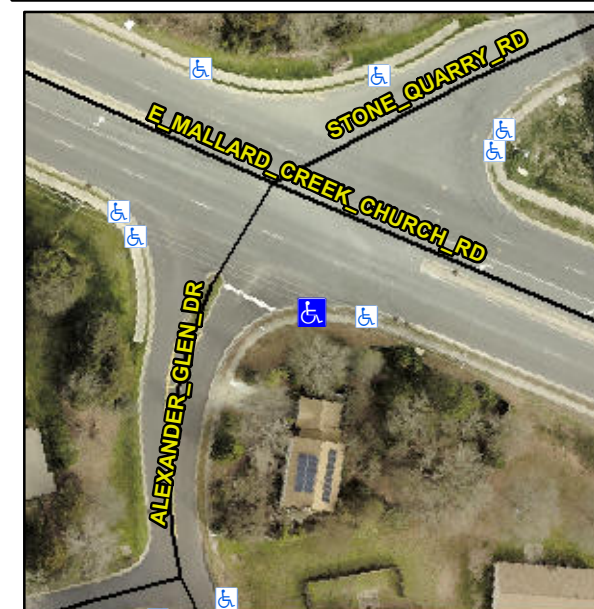
Compliance	Description	Data	Compliance	Description	Data
N/A	Ramp Length (in)	68.0	No	Ramp Slope (%)	9.0
No	Ramp Width (in)	47.0	No	Ramp XSlope (%)	5.0
N/A	Flare Type LT	N/A	N/A	Flare Type RT	N/A
N/A	Flare Slope LT (%)	N/A	N/A	Flare Slope RT (%)	N/A
N/A	Flare Traversable LT?	N/A	N/A	Flare Traversable RT?	N/A
N/A	Landing Length (in)	N/A	N/A	DWS Provided?	N/A
N/A	Landing Width (in)	N/A	N/A	DWS Contrast?	N/A
N/A	Landing Slope (%)	N/A	N/A	DWS Length (in)	N/A
N/A	Landing X Slope (%)	N/A	N/A	DWS Full Width?	N/A
N/A	Landing Curb? (Y/N)	N/A	N/A	DWS Offset (in)	N/A
N/A	Shared Landing?	N/A			
N/A	Gutter Ponding?	N/A	N/A	Gutter Slope (%)	N/A
N/A	Gutter Lip Ht (in)	N/A	N/A	Gutter X Slope (%)	N/A
N/A	Painted X Walk1?	No	N/A	Painted X Walk2?	N/A
	X Walk 1 Direction	To NW		X Walk 2 Direction	N/A
N/A	X Walk 1 Width (in)	N/A	N/A	X Walk 2 Width (in)	N/A
	X Walk 1 Slope (%)	2.7		X Walk 2 Slope (%)	N/A
	X Walk 1 X Slope (%)	3.8		X Walk 2 X Slope (%)	N/A

N/A	Ramp inside XWalk1?	N/A	N/A	Ramp inside XWalk2?	N/A
	Road Slope (%)	N/A	N/A	Clear Space?	N/A
	Road X Slope (%)	N/A	N/A	Clear Space to XWalk (in)	N/A
N/A	Any Obstructions?	N/A	N/A	Storm Grate/Utility Hazard?	N/A
	Obstruction Type			Storm Grate/Utility Type	
		N/A			N/A
			Yes	Surface Condition? (G/P)	Good

Possible Solutions:

**Remove & Replace Entire Ramp.**

**R304.5.1, R304.2.2, R304.5.3**
