Access Compliance Report

Public Rights-of-Way

(Curb Ramps)

Intersection ID: 15495	Main Street: CHEROKEE_RD	Cross Street: EASTOVER_RD	Location: NE
ADA ID: CBE08A81F5AB	Ramp Type: PerpDiag	Initial Pass/Fail: Fail	Overall Compliance: No
Severity Score: 12.5			
Codes/Mitigation Info/Possible Solution		Field Measurements/Component Compliance

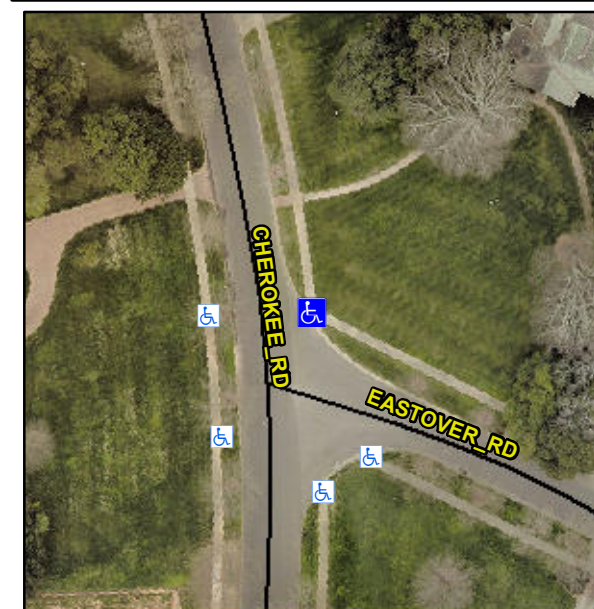
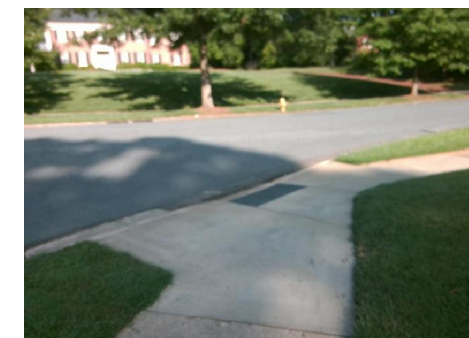
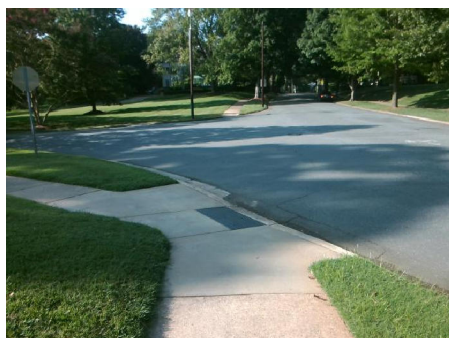
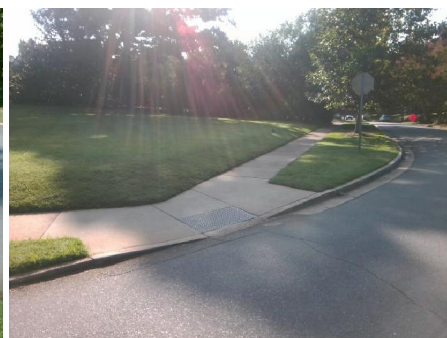
Not Found, R304.2.2

Compliance	Description	Data	Compliance	Description	Data
N/A	Ramp Length (in)	63.0	No	Ramp Slope (%)	9.9
Yes	Ramp Width (in)	48.0	Yes	Ramp XSlope (%)	2.0
N/A	Flare Type LT	N/A	N/A	Flare Type RT	N/A
N/A	Flare Slope LT (%)	N/A	N/A	Flare Slope RT (%)	N/A
N/A	Flare Traversable LT?	N/A	N/A	Flare Traversable RT?	N/A
N/A	Landing Length (in)	N/A	N/A	DWS Provided?	N/A
N/A	Landing Width (in)	N/A	N/A	DWS Contrast?	N/A
N/A	Landing Slope (%)	N/A	N/A	DWS Length (in)	N/A
N/A	Landing X Slope (%)	N/A	N/A	DWS Full Width?	N/A
N/A	Landing Curb? (Y/N)	N/A	N/A	DWS Offset (in)	N/A
N/A	Shared Landing?	N/A			
N/A	Gutter Ponding?	N/A	N/A	Gutter Slope (%)	N/A
N/A	Gutter Lip Ht (in)	N/A	N/A	Gutter X Slope (%)	N/A
N/A	Painted X Walk1?	No	N/A	Painted X Walk2?	No
	X Walk 1 Direction	To NW		X Walk 2 Direction	To S
N/A	X Walk 1 Width (in)	N/A	N/A	X Walk 2 Width (in)	N/A
	X Walk 1 Slope (%)	5.6		X Walk 2 Slope (%)	2.4
	X Walk 1 X Slope (%)	0.6		X Walk 2 X Slope (%)	8.2

N/A	Ramp inside XWalk1?	N/A	N/A	Ramp inside XWalk2?	N/A
	Road Slope (%)	4.5	N/A	Clear Space?	N/A
	Road X Slope (%)	10.2	N/A	Clear Space to XWalk (in)	N/A
N/A	Any Obstructions?	N/A	N/A	Storm Grate/Utility Hazard?	N/A
	Obstruction Type			Storm Grate/Utility Type	
		N/A			N/A
			Yes	Surface Condition? (G/P)	Good

Remove & Replace Curb Ramp With Two New Directional Ramps or Equivalent.

Total Cost: \$ 3200.00
