Access Compliance Report

Public Rights-of-Way

(Curb Ramps)

Intersection ID: 10040202	Main Street: TYVOLA_RD	Cross Street: N/A	Location: SW
ADA ID: CBECA09A15C7	Ramp Type: PerpDiag	Initial Pass/Fail: Fail	Overall Compliance: No
Severity Score: 33.75			
Codes/Mitigation Info/Possible Solution		Field Measurements/Component Compliance

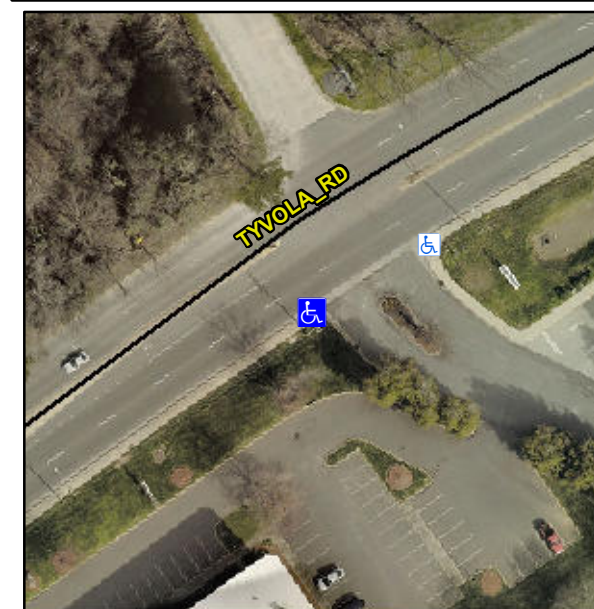
Compliance	Description	Data	Compliance	Description	Data
N/A	Ramp Length (in)	63.5	No	Ramp Slope (%)	9.9
No	Ramp Width (in)	37.0	No	Ramp XSlope (%)	5.3
N/A	Flare Type LT	N/A	N/A	Flare Type RT	N/A
N/A	Flare Slope LT (%)	N/A	N/A	Flare Slope RT (%)	N/A
N/A	Flare Traversable LT?	N/A	N/A	Flare Traversable RT?	N/A
N/A	Landing Length (in)	N/A	N/A	DWS Provided?	N/A
N/A	Landing Width (in)	N/A	N/A	DWS Contrast?	N/A
N/A	Landing Slope (%)	N/A	N/A	DWS Length (in)	N/A
N/A	Landing X Slope (%)	N/A	N/A	DWS Full Width?	N/A
N/A	Landing Curb? (Y/N)	N/A	N/A	DWS Offset (in)	N/A
N/A	Shared Landing?	N/A			
N/A	Gutter Ponding?	N/A	N/A	Gutter Slope (%)	N/A
N/A	Gutter Lip Ht (in)	N/A	N/A	Gutter X Slope (%)	N/A
N/A	Painted X Walk1?	No	N/A	Painted X Walk2?	No
	X Walk 1 Direction	To NE		X Walk 2 Direction	To NW
N/A	X Walk 1 Width (in)	N/A	N/A	X Walk 2 Width (in)	N/A
	X Walk 1 Slope (%)	1.4		X Walk 2 Slope (%)	3.3
	X Walk 1 X Slope (%)	3.2		X Walk 2 X Slope (%)	2.5

N/A	Ramp inside XWalk1?	N/A	N/A	Ramp inside XWalk2?	N/A
	Road Slope (%)	2.4	N/A	Clear Space?	N/A
	Road X Slope (%)	2.5	N/A	Clear Space to XWalk (in)	N/A
N/A	Any Obstructions?	N/A	N/A	Storm Grate/Utility Hazard?	N/A
	Obstruction Type			Storm Grate/Utility Type	
		N/A			N/A
			Yes	Surface Condition? (G/P)	Good

Possible Solutions:

Remove & Replace Curb Ramp With Two New Directional Ramps or Equivalent.
