# Access Compliance Report

## Public Rights-of-Way

### (Curb Ramps)

| Intersection ID: 45492 | Main Street: COTTON_STAND_RD | Cross Street: TRIANGLE_PARK_RD | Location: SE |

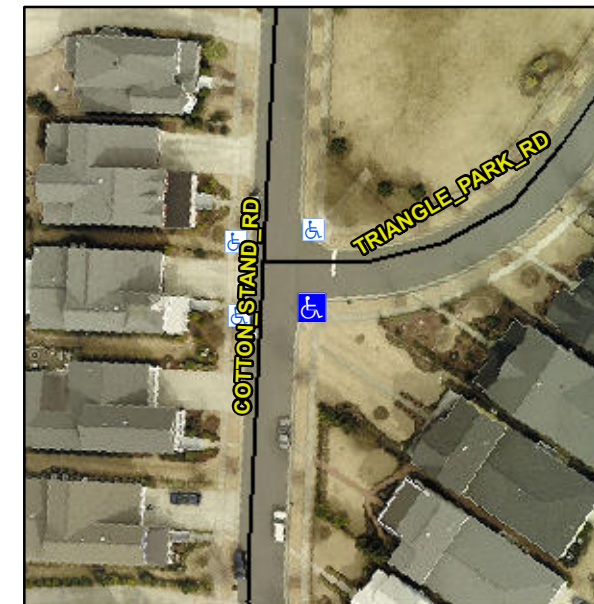
| ADA ID: CBF64532C792 | Ramp Type: PerpDiag | Initial Pass/Fail: Pass | Overall Compliance: No |
| Severity Score: 19.25 | | | |

**Not Found, R304.5.3, R304.2.1, R304.2.2-Perp, R304.3.2-Para, R302.7.2**

| Compliance | Description | Data | Compliance | Description | Data |
|---|---|---|---|---|---|
| Yes | Ramp Width (in) | 48.0 | No | Ramp XSlope (%) | 3.0 |
| No | Landing Length (in) | 47.0 | Yes | DWS Provided? | Yes |
| No | Landing Width (in) | 47.0 | Yes | DWS Contrast? | Yes |
| No | Landing Slope (%) | 2.4 | Yes | DWS Length (in) | 24.5 |
| No | Landing X Slope (%) | 2.3 | Yes | DWS Full Width? | Yes |
| No | Gutter Lip Ht (in) | 1.0 | Yes | Gutter X Slope (%) | 1.3 |

**Remove & Replace Curb Ramp With Two New Directional Ramps or Equivalent.**

Total Cost: \$ 3200.00

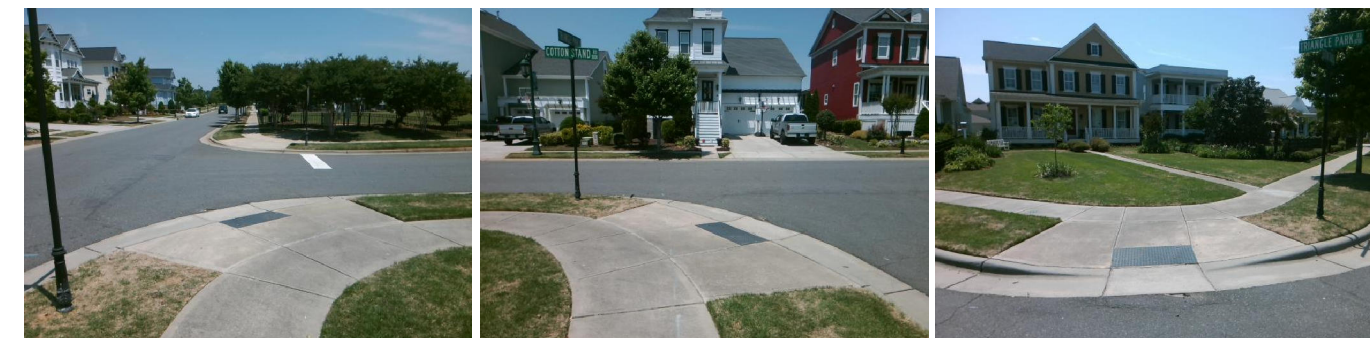
Street 1 Name TRIANGLE PARK RD  
 Stop Condition-Street 2 StopSign  
 Street 2 Name COTTON STAND RD  
 Stop Condition-Street 1 None
