Access Compliance Report

Public Rights-of-Way

(Curb Ramps)

Intersection ID: 6943	Main Street: BEATTIES_FORD_RD	Cross Street: CINDY_LN	Location: SE
ADA ID: CBF6551A4FB1	Ramp Type: PerpDiag	Initial Pass/Fail: Fail	Overall Compliance: No
Severity Score: 33.75			
Codes/Mitigation Info/Possible Solution		Field Measurements/Component Compliance

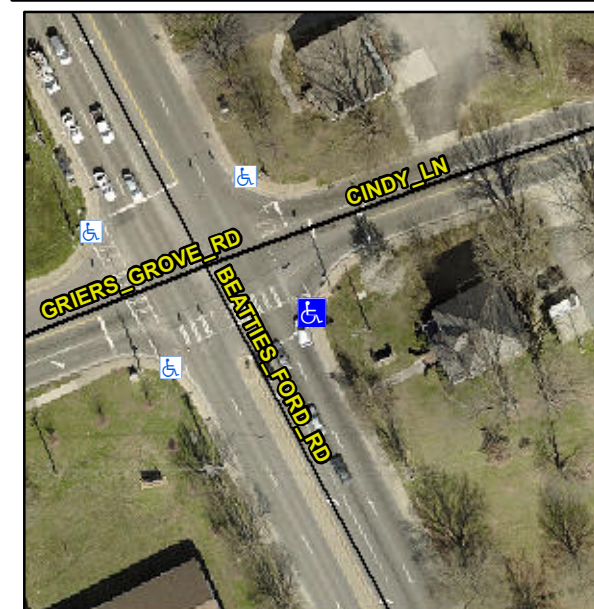
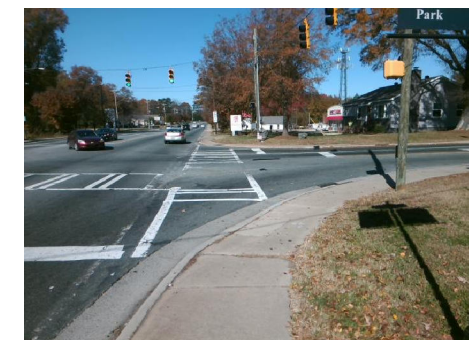
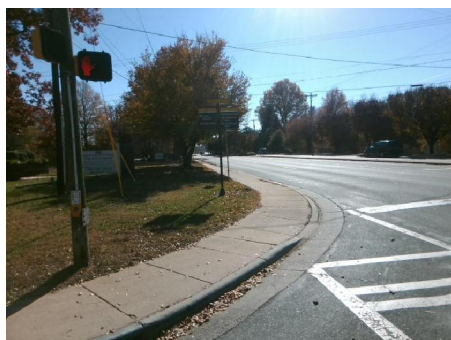
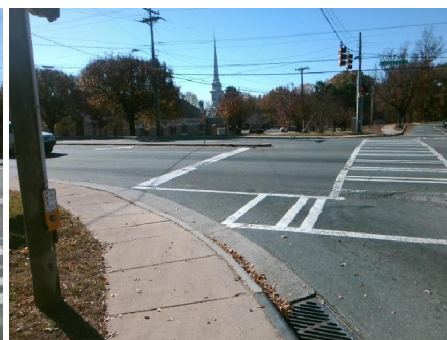
Not Found, R304.5.1, R304.2.2

Compliance	Description	Data	Compliance	Description	Data
N/A	Ramp Length (in)	58.0	No	Ramp Slope (%)	12.6
No	Ramp Width (in)	46.0	Yes	Ramp XSlope (%)	1.4
N/A	Flare Type LT	N/A	N/A	Flare Type RT	N/A
N/A	Flare Slope LT (%)	N/A	N/A	Flare Slope RT (%)	N/A
N/A	Flare Traversable LT?	N/A	N/A	Flare Traversable RT?	N/A
N/A	Landing Length (in)	N/A	N/A	DWS Provided?	N/A
N/A	Landing Width (in)	N/A	N/A	DWS Contrast?	N/A
N/A	Landing Slope (%)	N/A	N/A	DWS Length (in)	N/A
N/A	Landing X Slope (%)	N/A	N/A	DWS Full Width?	N/A
N/A	Landing Curb? (Y/N)	N/A	N/A	DWS Offset (in)	N/A
N/A	Shared Landing?	N/A			
N/A	Gutter Ponding?	N/A	N/A	Gutter Slope (%)	N/A
N/A	Gutter Lip Ht (in)	N/A	N/A	Gutter X Slope (%)	N/A
N/A	Painted X Walk1?	Yes	N/A	Painted X Walk2?	Yes
	X Walk 1 Direction	To NW		X Walk 2 Direction	To W
N/A	X Walk 1 Width (in)	90.5	N/A	X Walk 2 Width (in)	114.0
	X Walk 1 Slope (%)	0.7		X Walk 2 Slope (%)	2.7
	X Walk 1 X Slope (%)	0.0		X Walk 2 X Slope (%)	0.3

N/A	Ramp inside XWalk1?	Yes	N/A	Ramp inside XWalk2?	Yes
	Road Slope (%)	1.5	N/A	Clear Space?	N/A
	Road X Slope (%)	0.6	N/A	Clear Space to XWalk (in)	N/A
N/A	Any Obstructions?	N/A	N/A	Storm Grate/Utility Hazard?	N/A
	Obstruction Type			Storm Grate/Utility Type	
		N/A			N/A
		Yes		Surface Condition? (G/P)	Good

Remove & Replace Curb Ramp With Two New Directional Ramps or Equivalent.
