Intersection ID: 17851	Main Street: SCALEYBARK_RD	Cross Street: BROOKRUN_DR	Location:	NW
ADA ID: CBF8F94463EA	Ramp Type: ParaDiag	Initial Pass/Fail: Pass	Overall Compliance: No	Severity Score: 0

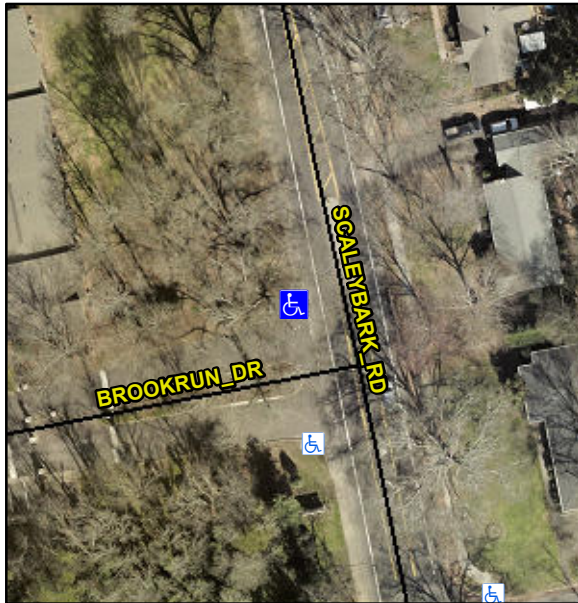
R304.2.1, R304.5.3

Compliance		Description	Data	Compliance		Description	Data
N/A		Ramp Length LT (in)	N/A	N/A		Ramp Length RT (in)	49.0
N/A		Ramp Width LT (in)	N/A	Yes		Ramp Width RT (in)	59.0
N/A		Ramp Slope LT (%)	N/A	Yes		Ramp Slope RT (%)	7.0
N/A		Ramp XSlope LT (%)	N/A	Yes		Ramp XSlope RT (%)	0.8
No		Landing Length (in)	58.0	Yes		DWS Provided?	Yes
Yes		Landing Width (in)	48.0	Yes		DWS Contrast?	Yes
Yes		Landing Slope (%)	0.6	Yes		DWS Length (in)	24.5
No		Landing X Slope (%)	3.6	Yes		DWS Full Width?	Yes
N/A		Landing Curb? (Y/N)	Yes	Yes		DWS Offset (in)	2.0
N/A		Shared Landing?	No				
Yes		Gutter Ponding?	No	Yes		Gutter Slope (%)	4.6
Yes		Gutter Lip Ht (in)	0.0	No		Gutter X Slope (%)	2.7
N/A		Painted X Walk1?	No	N/A		Painted X Walk2?	No
		X Walk 1 Direction	To S			X Walk 2 Direction	To E
N/A		X Walk 1 Width (in)	N/A	N/A		X Walk 2 Width (in)	N/A
		X Walk 1 Slope (%)	1.3			X Walk 2 Slope (%)	4.3
		X Walk 1 X Slope (%)	2.3			X Walk 2 X Slope (%)	1.1

N/A		Ramp inside XWalk1?	N/A	N/A		Ramp inside XWalk2?	N/A
		Road Slope (%)	0.3	N/A		Clear Space?	Yes
		Road X Slope (%)	5.2	N/A		Clear Space to XWalk (in)	N/A
Yes		Any Obstructions?	No	Yes		Storm Grate/Utility Hazard?	No
		Obstruction Type				Storm Grate/Utility Type	
			N/A				N/A
				Yes		Surface Condition? (G/P)	Good
				N/A		Curb Slope (%)	7.2

Remove & Replace Curb Ramp With Two New Directional Ramps or Equivalent. Remove & Replace Gutter.
