# Access Compliance Report

## Public Rights-of-Way

### (Curb Ramps)

| Intersection ID: 50633 | Main Street: BLUE_BLOSSOM_RD | Cross Street: CORAL_ROSE_RD | Location: NE |

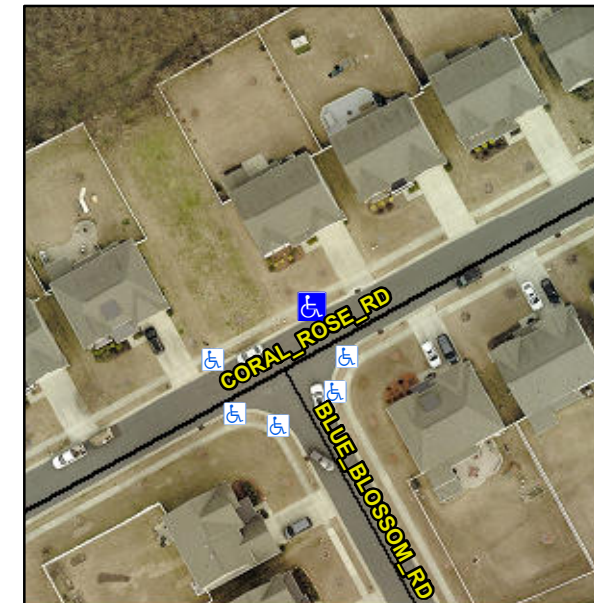
| ADA ID: CBFDF70837E6 | Ramp Type: BlendTrans1 | Initial Pass/Fail: Pass | Overall Compliance: No |
| | | Severity Score: 5 | |

**Not Found, R304.5.3, R305.2, R304.5.4**

| Compliance | Description | Data | Compliance | Description | Data |
|---|---|---|---|---|---|
| No | Landing X Slope (%) | 3.1 | Yes | DWS Full Width? | Yes |
| N/A | Landing Curb? (Y/N) | No | No | DWS Offset (in) | 5.0 |
| Yes | Gutter Ponding? | No | No | Gutter Slope (%) | 6.5 |
| | | | No | Curb Slope (%) | 24.3 |

**Remove & Replace Curb Ramp With Two New Directional Ramps or Equivalent. Remove & Replace Gutter.**
