Access Compliance Report

Public Rights-of-Way

(Curb Ramps)

Intersection ID: 14672	Main Street: NORFOLK_AV	Cross Street: REMOUNT_RD	Location: S
ADA ID: CC0141872F79	Ramp Type: PerpDiag	Initial Pass/Fail: Fail	Overall Compliance: No
		Severity Score: 37.5

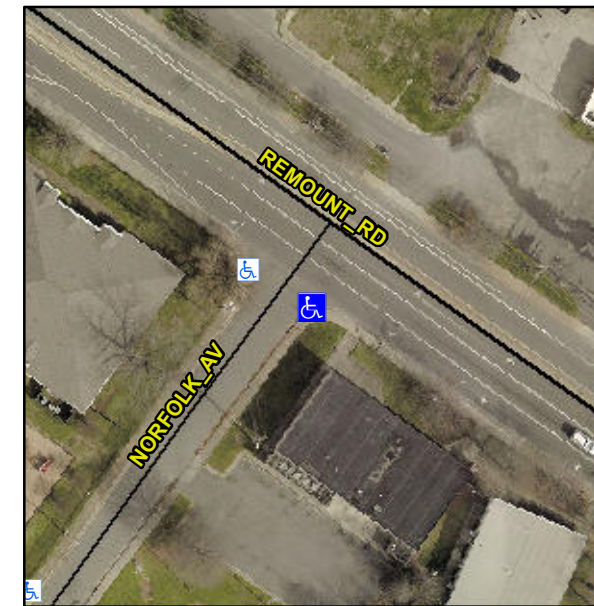
Not Found, R304.2.2, R304.5.3

Compliance	Description	Data	Compliance	Description	Data
N/A	Ramp Length (in)	60.0	No	Ramp Slope (%)	12.1
Yes	Ramp Width (in)	48.0	No	Ramp XSlope (%)	5.7
N/A	Flare Type LT	N/A	N/A	Flare Type RT	N/A
N/A	Flare Slope LT (%)	N/A	N/A	Flare Slope RT (%)	N/A
N/A	Flare Traversable LT?	N/A	N/A	Flare Traversable RT?	N/A
N/A	Landing Length (in)	N/A	N/A	DWS Provided?	N/A
N/A	Landing Width (in)	N/A	N/A	DWS Contrast?	N/A
N/A	Landing Slope (%)	N/A	N/A	DWS Length (in)	N/A
N/A	Landing X Slope (%)	N/A	N/A	DWS Full Width?	N/A
N/A	Landing Curb? (Y/N)	N/A	N/A	DWS Offset (in)	N/A
N/A	Shared Landing?	N/A			
N/A	Gutter Ponding?	Yes	N/A	Gutter Slope (%)	N/A
N/A	Gutter Lip Ht (in)	N/A	N/A	Gutter X Slope (%)	N/A
N/A	Painted X Walk1?	No	N/A	Painted X Walk2?	No
	X Walk 1 Direction	To NE		X Walk 2 Direction	To NW
N/A	X Walk 1 Width (in)	N/A	N/A	X Walk 2 Width (in)	N/A
	X Walk 1 Slope (%)	0.9		X Walk 2 Slope (%)	2.6
	X Walk 1 X Slope (%)	2.6		X Walk 2 X Slope (%)	0.6

N/A	Ramp inside XWalk1?	N/A	N/A	Ramp inside XWalk2?	N/A
	Road Slope (%)	2.9	N/A	Clear Space?	N/A
	Road X Slope (%)	1.0	N/A	Clear Space to XWalk (in)	N/A
N/A	Any Obstructions?	N/A	N/A	Storm Grate/Utility Hazard?	N/A
	Obstruction Type			Storm Grate/Utility Type	
		N/A			N/A
		Yes		Surface Condition? (G/P)	Good

Remove & Replace Curb Ramp With Two New Directional Ramps or Equivalent.

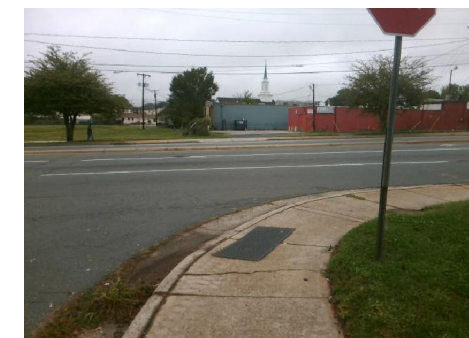
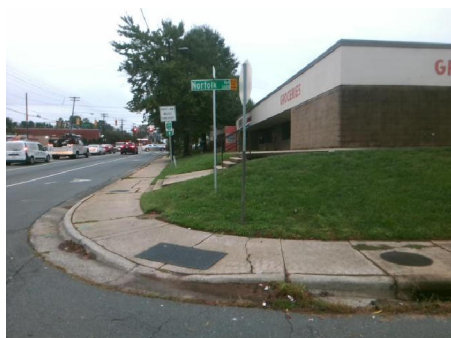
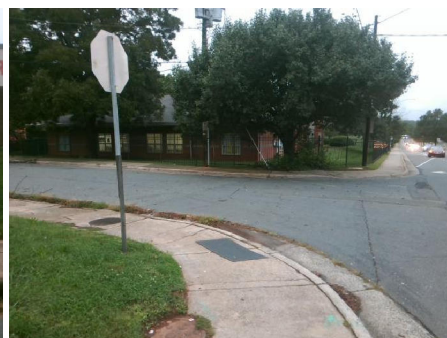
Street 1 Name REMOUNT RD
 Stop Condition-Street 2 None
 Street 2 Name NORFOLK AV
 Stop Condition-Street 1 StopSign
