Access Compliance Report

Public Rights-of-Way

(Curb Ramps)

Intersection ID: 16237	Main Street: ELLENWOOD_PL	Cross Street: FREELAND_LN	Location: NE
ADA ID: CC17184A8353	Ramp Type: PerpDiag	Initial Pass/Fail: Fail	Overall Compliance: No
		Severity Score: 8.75

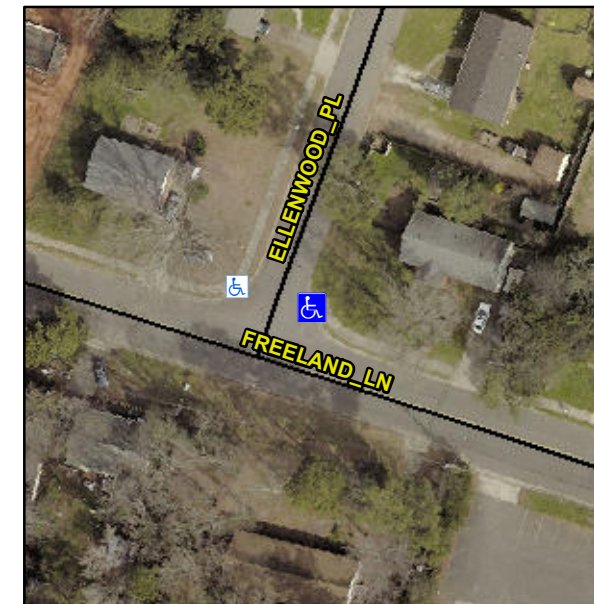
Not Found, R304.5.1

Compliance	Description	Data	Compliance	Description	Data
N/A	Ramp Length (in)	94.0	Yes	Ramp Slope (%)	6.5
No	Ramp Width (in)	47.0	Yes	Ramp XSlope (%)	0.6
N/A	Flare Type LT	N/A	N/A	Flare Type RT	N/A
N/A	Flare Slope LT (%)	N/A	N/A	Flare Slope RT (%)	N/A
N/A	Flare Traversable LT?	N/A	N/A	Flare Traversable RT?	N/A
N/A	Landing Length (in)	N/A	N/A	DWS Provided?	N/A
N/A	Landing Width (in)	N/A	N/A	DWS Contrast?	N/A
N/A	Landing Slope (%)	N/A	N/A	DWS Length (in)	N/A
N/A	Landing X Slope (%)	N/A	N/A	DWS Full Width?	N/A
N/A	Landing Curb? (Y/N)	N/A	N/A	DWS Offset (in)	N/A
N/A	Shared Landing?	N/A			
N/A	Gutter Ponding?	N/A	N/A	Gutter Slope (%)	N/A
N/A	Gutter Lip Ht (in)	N/A	N/A	Gutter X Slope (%)	N/A
N/A	Painted X Walk1?	No	N/A	Painted X Walk2?	No
	X Walk 1 Direction	To NW		X Walk 2 Direction	To SW
N/A	X Walk 1 Width (in)	N/A	N/A	X Walk 2 Width (in)	N/A
	X Walk 1 Slope (%)	2.6		X Walk 2 Slope (%)	3.2
	X Walk 1 X Slope (%)	1.4		X Walk 2 X Slope (%)	2.3

N/A	Ramp inside XWalk1?	N/A	N/A	Ramp inside XWalk2?	N/A
	Road Slope (%)	0.2	N/A	Clear Space?	N/A
	Road X Slope (%)	6.5	N/A	Clear Space to XWalk (in)	N/A
N/A	Any Obstructions?	N/A	N/A	Storm Grate/Utility Hazard?	N/A
	Obstruction Type			Storm Grate/Utility Type	
		N/A			N/A
			Yes	Surface Condition? (G/P)	Good

Remove & Replace Curb Ramp With Two New Directional Ramps or Equivalent.
