Access Compliance Report

Public Rights-of-Way

(Curb Ramps)

Intersection ID: 42705	Main Street: PARK_RD	Cross Street: SHARON_RD	Location: SE
ADA ID: CC2E849D4F3C	Ramp Type: Perp	Initial Pass/Fail: Fail	Overall Compliance: No
		Severity Score: 12.5

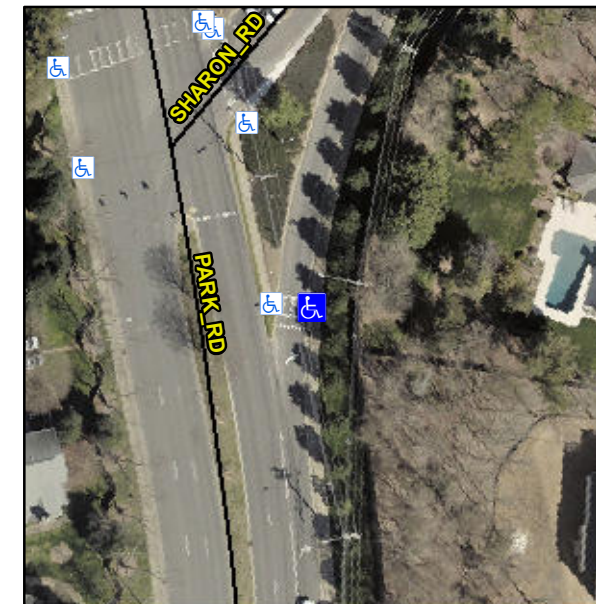
Not Found, R304.2.2

Compliance	Description	Data	Compliance	Description	Data
N/A	Ramp Length (in)	61.0	No	Ramp Slope (%)	9.6
Yes	Ramp Width (in)	48.0	Yes	Ramp XSlope (%)	0.5
N/A	Flare Type LT	N/A	N/A	Flare Type RT	N/A
N/A	Flare Slope LT (%)	N/A	N/A	Flare Slope RT (%)	N/A
N/A	Flare Traversable LT?	N/A	N/A	Flare Traversable RT?	N/A
N/A	Landing Length (in)	N/A	N/A	DWS Provided?	N/A
N/A	Landing Width (in)	N/A	N/A	DWS Contrast?	N/A
N/A	Landing Slope (%)	N/A	N/A	DWS Length (in)	N/A
N/A	Landing X Slope (%)	N/A	N/A	DWS Full Width?	N/A
N/A	Landing Curb? (Y/N)	N/A	N/A	DWS Offset (in)	N/A
N/A	Shared Landing?	N/A			
N/A	Gutter Ponding?	N/A	N/A	Gutter Slope (%)	N/A
N/A	Gutter Lip Ht (in)	N/A	N/A	Gutter X Slope (%)	N/A
N/A	Painted X Walk1?	Yes	N/A	Painted X Walk2?	N/A
	X Walk 1 Direction	To NW		X Walk 2 Direction	N/A
N/A	X Walk 1 Width (in)	109.0	N/A	X Walk 2 Width (in)	N/A
	X Walk 1 Slope (%)	1.9		X Walk 2 Slope (%)	N/A
	X Walk 1 X Slope (%)	1.7		X Walk 2 X Slope (%)	N/A

N/A	Ramp inside XWalk1?	Yes	N/A	Ramp inside XWalk2?	N/A
	Road Slope (%)	N/A	N/A	Clear Space?	N/A
	Road X Slope (%)	N/A	N/A	Clear Space to XWalk (in)	N/A
N/A	Any Obstructions?	N/A	N/A	Storm Grate/Utility Hazard?	N/A
	Obstruction Type			Storm Grate/Utility Type	
		N/A			N/A
		Yes		Surface Condition? (G/P)	Good

Remove & Replace Entire Ramp.

Total Cost: \$ 1850.00
