Access Compliance Report

Public Rights-of-Way

(Curb Ramps)

Intersection ID: N/A	Main Street: MONROE_RD	Cross Street: BUFORD_AV	Location: SE
ADA ID: CC30B0593F52	Ramp Type: PerpDiag	Initial Pass/Fail: Fail	Overall Compliance: No
Codes/Mitigation Info/Possible Solution		Field Measurements/Component Compliance	
Severity Score: 21.25

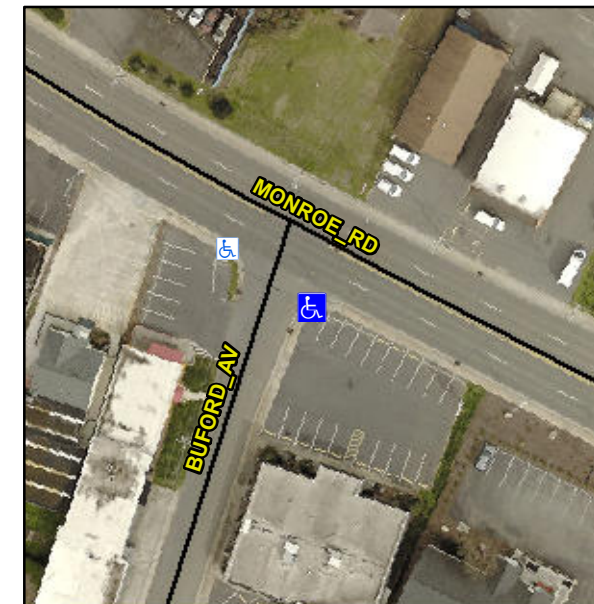
Not Found, R304.5.1, R304.2.2

Compliance	Description	Data	Compliance	Description	Data
N/A	Ramp Length (in)	49.0	No	Ramp Slope (%)	10.8
No	Ramp Width (in)	45.0	Yes	Ramp XSlope (%)	0.5
N/A	Flare Type LT	N/A	N/A	Flare Type RT	N/A
N/A	Flare Slope LT (%)	N/A	N/A	Flare Slope RT (%)	N/A
N/A	Flare Traversable LT?	N/A	N/A	Flare Traversable RT?	N/A
N/A	Landing Length (in)	N/A	N/A	DWS Provided?	N/A
N/A	Landing Width (in)	N/A	N/A	DWS Contrast?	N/A
N/A	Landing Slope (%)	N/A	N/A	DWS Length (in)	N/A
N/A	Landing X Slope (%)	N/A	N/A	DWS Full Width?	N/A
N/A	Landing Curb? (Y/N)	N/A	N/A	DWS Offset (in)	N/A
N/A	Shared Landing?	N/A			
N/A	Gutter Ponding?	N/A	N/A	Gutter Slope (%)	N/A
N/A	Gutter Lip Ht (in)	N/A	N/A	Gutter X Slope (%)	N/A
N/A	Painted X Walk1?	No	N/A	Painted X Walk2?	No
	X Walk 1 Direction	To NE		X Walk 2 Direction	To NW
N/A	X Walk 1 Width (in)	N/A	N/A	X Walk 2 Width (in)	N/A
	X Walk 1 Slope (%)	3.0		X Walk 2 Slope (%)	1.2
	X Walk 1 X Slope (%)	0.4		X Walk 2 X Slope (%)	1.8

N/A	Ramp inside XWalk1?	N/A	N/A	Ramp inside XWalk2?	N/A
	Road Slope (%)	0.9	N/A	Clear Space?	N/A
	Road X Slope (%)	1.0	N/A	Clear Space to XWalk (in)	N/A
N/A	Any Obstructions?	N/A	N/A	Storm Grate/Utility Hazard?	N/A
	Obstruction Type			Storm Grate/Utility Type	
		N/A			N/A
			Yes	Surface Condition? (G/P)	Good

Remove & Replace Curb Ramp With Two New Directional Ramps or Equivalent.

Total Cost: \$ 3200.00
