# Access Compliance Report

## Public Rights-of-Way

### (Curb Ramps)

Intersection ID: 10041902	Main Street: WIND_CHIME_CT	Cross Street: N/A	Location: E
ADA ID: CC365249177C	Ramp Type: Perp	Initial Pass/Fail: Fail	Overall Compliance: No
Severity Score: 22.5			
Codes/Mitigation Info/Possible Solution		Field Measurements/Component Compliance

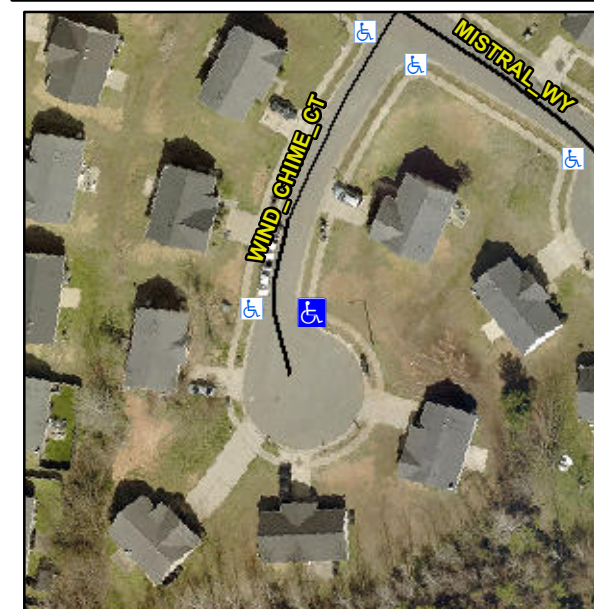
**Not Found, R304.5.1, R304.2.2**

Compliance	Description	Data	Compliance	Description	Data
N/A	Ramp Length (in)	48.0	No	Ramp Slope (%)	9.2
No	Ramp Width (in)	47.0	Yes	Ramp XSlope (%)	2.8
N/A	Flare Type LT	N/A	N/A	Flare Type RT	N/A
N/A	Flare Slope LT (%)	N/A	N/A	Flare Slope RT (%)	N/A
N/A	Flare Traversable LT?	N/A	N/A	Flare Traversable RT?	N/A
N/A	Landing Length (in)	N/A	N/A	DWS Provided?	N/A
N/A	Landing Width (in)	N/A	N/A	DWS Contrast?	N/A
N/A	Landing Slope (%)	N/A	N/A	DWS Length (in)	N/A
N/A	Landing X Slope (%)	N/A	N/A	DWS Full Width?	N/A
N/A	Landing Curb? (Y/N)	N/A	N/A	DWS Offset (in)	N/A
N/A	Shared Landing?	N/A			
N/A	Gutter Ponding?	N/A	N/A	Gutter Slope (%)	N/A
N/A	Gutter Lip Ht (in)	N/A	N/A	Gutter X Slope (%)	N/A
N/A	Painted X Walk1?	No	N/A	Painted X Walk2?	N/A
	X Walk 1 Direction	To W		X Walk 2 Direction	N/A
N/A	X Walk 1 Width (in)	N/A	N/A	X Walk 2 Width (in)	N/A
	X Walk 1 Slope (%)	1.1		X Walk 2 Slope (%)	N/A
	X Walk 1 X Slope (%)	3.8		X Walk 2 X Slope (%)	N/A

N/A	Ramp inside XWalk1?	N/A	N/A	Ramp inside XWalk2?	N/A
	Road Slope (%)	N/A	N/A	Clear Space?	N/A
	Road X Slope (%)	N/A	N/A	Clear Space to XWalk (in)	N/A
N/A	Any Obstructions?	N/A	N/A	Storm Grate/Utility Hazard?	N/A
	Obstruction Type			Storm Grate/Utility Type	
		N/A			N/A
			Yes	Surface Condition? (G/P)	Good

**Remove & Replace Entire Ramp.**

Total Cost: \$ 1850.00
