# Access Compliance Report

## Public Rights-of-Way

### (Curb Ramps)

Intersection ID: 23329	Main Street: GLENEAGLES_RD	Cross Street: PARK_RD	Location: SE
ADA ID: CC37BAC4D2D8	Ramp Type: Perp	Initial Pass/Fail: Fail	Overall Compliance: No
Severity Score: 12.5			
Codes/Mitigation Info/Possible Solution		Field Measurements/Component Compliance

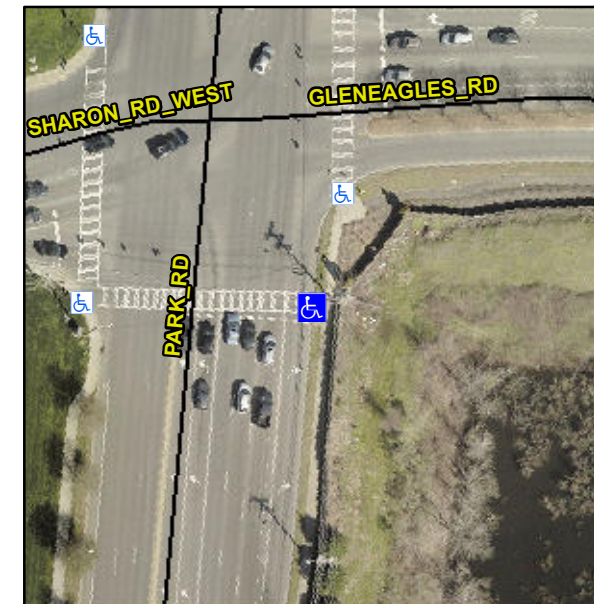
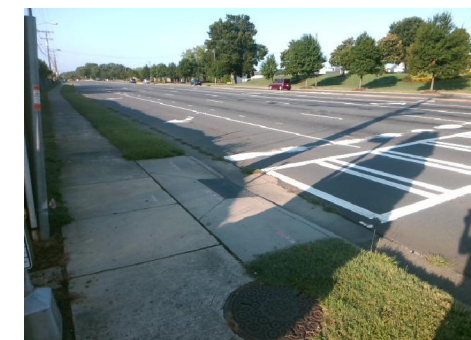
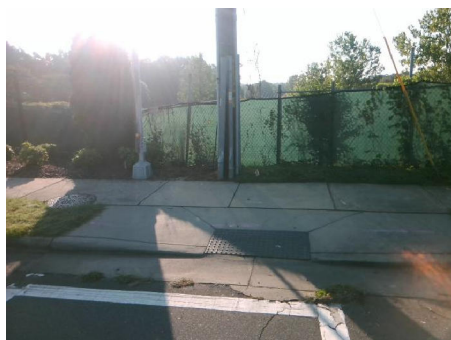
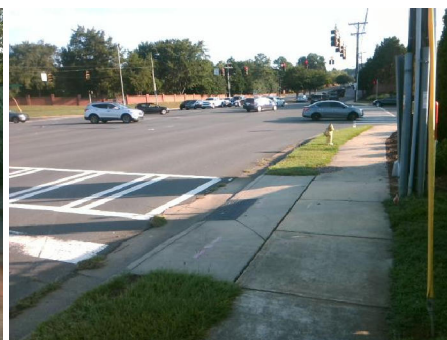
Compliance	Description	Data	Compliance	Description	Data
N/A	Ramp Length (in)	47.5	No	Ramp Slope (%)	8.5
Yes	Ramp Width (in)	48.0	Yes	Ramp XSlope (%)	0.4
N/A	Flare Type LT	N/A	N/A	Flare Type RT	N/A
N/A	Flare Slope LT (%)	N/A	N/A	Flare Slope RT (%)	N/A
N/A	Flare Traversable LT?	N/A	N/A	Flare Traversable RT?	N/A
N/A	Landing Length (in)	N/A	N/A	DWS Provided?	N/A
N/A	Landing Width (in)	N/A	N/A	DWS Contrast?	N/A
N/A	Landing Slope (%)	N/A	N/A	DWS Length (in)	N/A
N/A	Landing X Slope (%)	N/A	N/A	DWS Full Width?	N/A
N/A	Landing Curb? (Y/N)	N/A	N/A	DWS Offset (in)	N/A
N/A	Shared Landing?	N/A			
N/A	Gutter Ponding?	N/A	N/A	Gutter Slope (%)	N/A
N/A	Gutter Lip Ht (in)	N/A	N/A	Gutter X Slope (%)	N/A
N/A	Painted X Walk1?	Yes	N/A	Painted X Walk2?	N/A
	X Walk 1 Direction	To NW		X Walk 2 Direction	N/A
N/A	X Walk 1 Width (in)	111.0	N/A	X Walk 2 Width (in)	N/A
	X Walk 1 Slope (%)	0.5		X Walk 2 Slope (%)	N/A
	X Walk 1 X Slope (%)	0.6		X Walk 2 X Slope (%)	N/A

N/A	Ramp inside XWalk1?	Yes	N/A	Ramp inside XWalk2?	N/A
	Road Slope (%)	N/A	N/A	Clear Space?	N/A
	Road X Slope (%)	N/A	N/A	Clear Space to XWalk (in)	N/A
N/A	Any Obstructions?	N/A	N/A	Storm Grate/Utility Hazard?	N/A
	Obstruction Type			Storm Grate/Utility Type	
		N/A			N/A
		Yes		Surface Condition? (G/P)	Good

**Remove & Replace Entire Ramp.**

**Not Found, R304.2.2**
