# Access Compliance Report

## Public Rights-of-Way

### (Curb Ramps)

| Intersection ID: 50245 | Main Street: HANBERRY_BV | Cross Street: PORTAFERRY_DR | Location: NW |

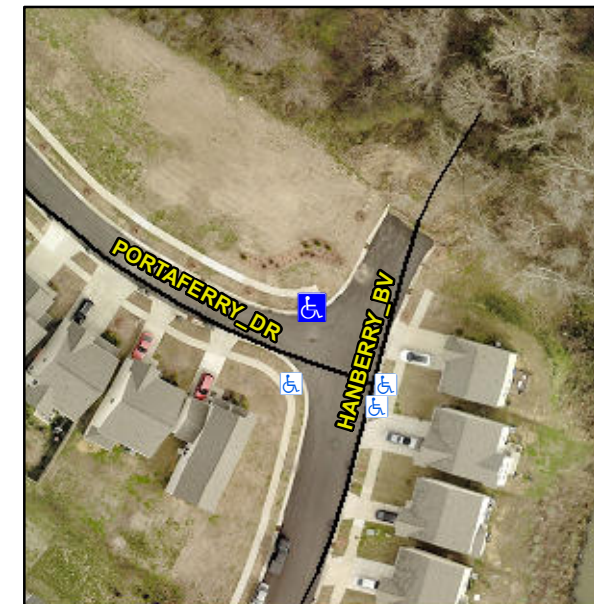
**NO RT SW**

**Not Found, R304.5.1**

| Compliance | Description | Data | Compliance | Description | Data |
|---|---|---|---|---|---|
| No | Ramp Width (in) | 33.0 | Yes | BlendTrans XSlope (%) | 1.4 |
| | | | No | Curb Slope (%) | 12.1 |

**Remove & Replace Curb Ramp With Two New Directional Ramps or Equivalent.**
