## **Access Compliance Report Public Rights-of-Way** (Curb Ramps)

Cross Street: N/A Location: Intersection ID: 10036687 Main Street: S CHURCH ST NW Ramp Type: Perp Initial Pass/Fail: Fail **Overall Compliance: No** 12.5 ADA ID: CC44BF2FC53C **Severity Score:**

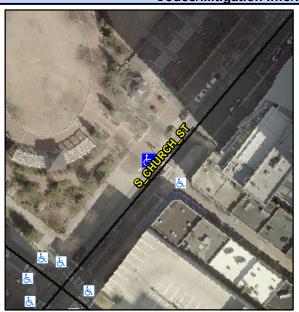
S CHURCH ST Street 1 Name Stop Condition-Street 2 None N/A Street 2 Name Stop Condition-Street 1 N/A Possible Solutions: Compliance Description Remove & Replace Entire Ramp. N/A Yes N/A N/A N/A N/A Surveyor Notes: N/A N/A PROW/ADA: Not Found, R304.5.3
