Access Compliance Report

Public Rights-of-Way

(Curb Ramps)

Intersection ID: N/A	Main Street: BRAWLEY LN	Cross Street: BRADSTREET COMMONS WY	Location: SE
ADA ID: CC495744F76E	Ramp Type: PerpDiag	Initial Pass/Fail: Fail	Overall Compliance: No
Codes/Mitigation Info/Possible Solution		Field Measurements/Component Compliance	
Severity Score: 8.75

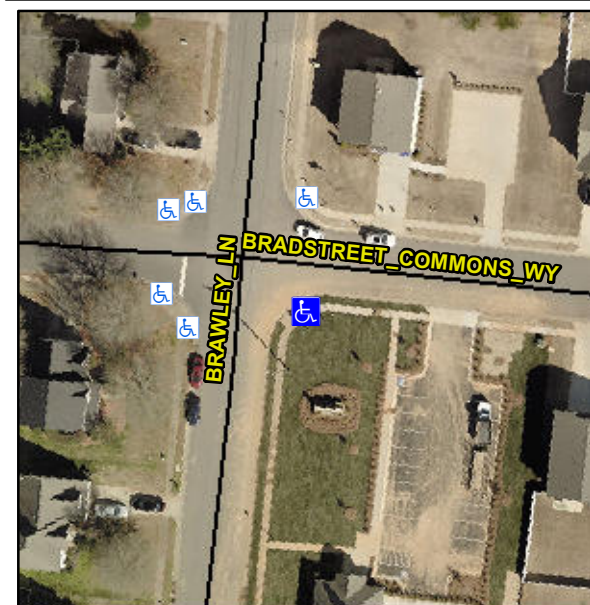
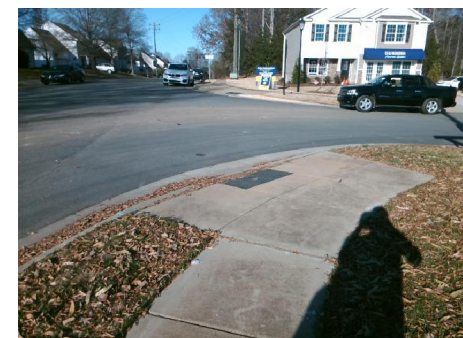
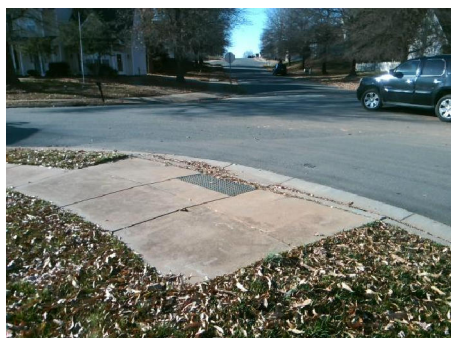
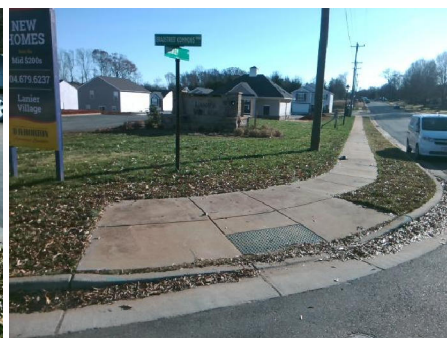
Compliance	Description	Data	Compliance	Description	Data
N/A	Ramp Length (in)	50.0	Yes	Ramp Slope (%)	6.2
No	Ramp Width (in)	45.0	Yes	Ramp XSlope (%)	0.5
N/A	Flare Type LT	N/A	N/A	Flare Type RT	N/A
N/A	Flare Slope LT (%)	N/A	N/A	Flare Slope RT (%)	N/A
N/A	Flare Traversable LT?	No	N/A	Flare Traversable RT?	No
N/A	Landing Length (in)	N/A	N/A	DWS Provided?	N/A
N/A	Landing Width (in)	N/A	N/A	DWS Contrast?	N/A
N/A	Landing Slope (%)	N/A	N/A	DWS Length (in)	N/A
N/A	Landing X Slope (%)	N/A	N/A	DWS Full Width?	N/A
N/A	Landing Curb? (Y/N)	N/A	N/A	DWS Offset (in)	N/A
N/A	Shared Landing?	N/A			
N/A	Gutter Ponding?	N/A	N/A	Gutter Slope (%)	N/A
N/A	Gutter Lip Ht (in)	N/A	N/A	Gutter X Slope (%)	N/A
N/A	Painted X Walk1?	No	N/A	Painted X Walk2?	No
	X Walk 1 Direction	To N		X Walk 2 Direction	To W
N/A	X Walk 1 Width (in)	N/A	N/A	X Walk 2 Width (in)	N/A
	X Walk 1 Slope (%)	1.9		X Walk 2 Slope (%)	1.7
	X Walk 1 X Slope (%)	0.9		X Walk 2 X Slope (%)	1.3

N/A	Ramp inside XWalk1?	N/A	N/A	Ramp inside XWalk2?	N/A
	Road Slope (%)	2.1	N/A	Clear Space?	N/A
	Road X Slope (%)	2.4	N/A	Clear Space to XWalk (in)	N/A
N/A	Any Obstructions?	N/A	N/A	Storm Grate/Utility Hazard?	N/A
	Obstruction Type			Storm Grate/Utility Type	
		N/A			N/A
			Yes	Surface Condition? (G/P)	Good

Remove & Replace Curb Ramp With Two New Directional Ramps or Equivalent.
