## **Access Compliance Report Public Rights-of-Way** (Curb Ramps)

Intersection ID: 52929 Main Street: ENGLISH\_OAK\_LEAF\_CT Cross Street: GRAY\_OAK\_LN Location: **Overall Compliance: No** ADA ID: CC4D2BA71CA4 Ramp Type: Perp Initial Pass/Fail: Fail Severity Score: 21.25

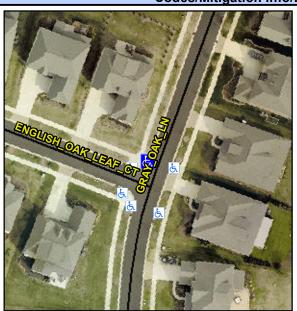
Field Measurements/Component Compliance						
Comp	liance Description	Data	Comp	liance Description	Data	
N/A	Ramp Length (in)	78.0	No	Ramp Slope (%)	8.4	
No	Ramp Width (in)	46.0	Yes	Ramp XSlope (%)	1.5	
N/A	Flare Type LT	N/A	N/A	Flare Type RT	N/A	
N/A	Flare Slope LT (%)	N/A	N/A	Flare Slope RT (%)	N/A	
N/A	Flare Traversable LT?	N/A	N/A	Flare Traversable RT?	N/A	
N/A	Landing Length (in)	N/A	N/A	DWS Provided?	N/A	
N/A	Landing Width (in)	N/A	N/A	DWS Contrast?	N/A	
N/A	Landing Slope (%)	N/A	N/A	DWS Length (in)	N/A	
N/A	Landing X Slope (%)	N/A	N/A	DWS Full Width?	N/A	
N/A	Landing Curb? (Y/N)	N/A	N/A	DWS Offset (in)	N/A	
N/A	Shared Landing?	N/A				
N/A	Gutter Ponding?	N/A	N/A	Gutter Slope (%)	N/A	
N/A	Gutter Lip Ht (in)	N/A	N/A	Gutter X Slope (%)	N/A	
N/A	Painted X Walk1?	No	N/A	Painted X Walk2?	N/A	
	X Walk 1 Direction	To SE		X Walk 2 Direction	N/A	
N/A	X Walk 1 Width (in)	N/A	N/A	X Walk 2 Width (in)	N/A	
	X Walk 1 Slope (%)	2.8		X Walk 2 Slope (%)	N/A

X Walk 1 X Slope (%)	1.6		X Walk 2 X Slope (%)	N/A	
N/A	Ramp inside XWalk1?	N/A	N/A	Ramp inside XWalk2?	N/A	
	Road Slope (%)	N/A	N/A	Clear Space?	N/A	
	Road X Slope (%)	N/A	N/A	Clear Space to XWalk (in)	N/A	
N/A	Any Obstructions?	N/A	N/A	Storm Grate/Utility Hazard?	N/A	
	Obstruction Type			Storm Grate/Utility Type		
		N/A			N/A	
			Yes	Surface Condition? (G/P)	Good

- USSIDIE SUIULIUII	
Possible Solutions:	Con
Remove & Replace Entire Ramp.	N/A
·	No
	N/A
	N/A
	N/A
	N/A
Surveyor Notes:	N/A
N/A	N/A
	N/A
	N/A
	N/A
PROW/ADA:	N/A
R304.5.1, R304.2.2	N/A
	N/A
	N/A
	N/A

1850.00
