# Access Compliance Report

## Public Rights-of-Way

### (Curb Ramps)

Intersection ID: 30633	Main Street: HADDONFIELD_PL	Cross Street: HUMBOLDT_DR	Location: NW
ADA ID: CC4EBFC138B3	Ramp Type: PerpDiag	Initial Pass/Fail: Fail	Overall Compliance: No
			Severity Score: 21.25

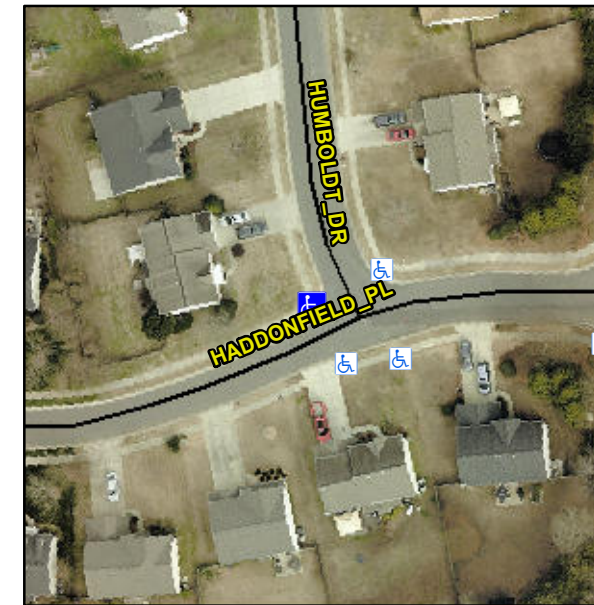
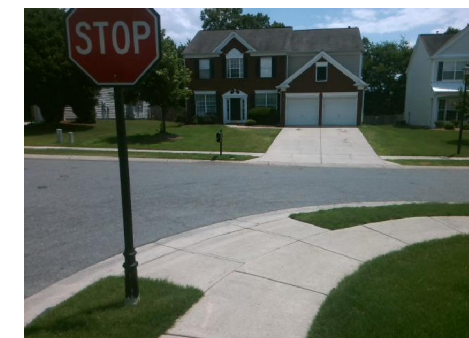
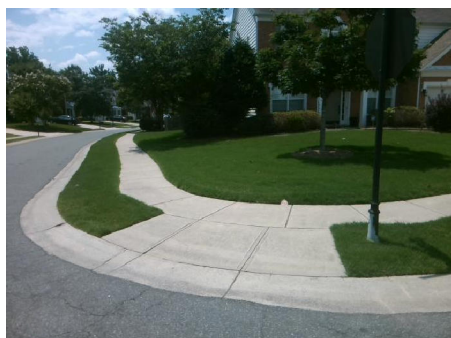
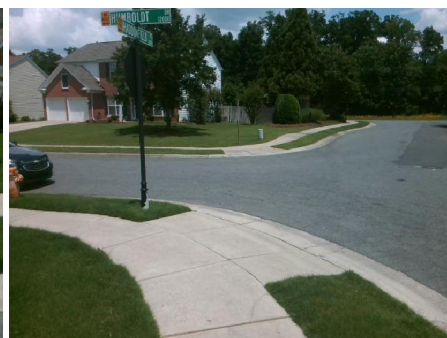
**Not Found, R304.5.1, R304.2.2**

Compliance	Description	Data	Compliance	Description	Data
N/A	Ramp Length (in)	50.0	No	Ramp Slope (%)	9.8
No	Ramp Width (in)	46.0	Yes	Ramp XSlope (%)	0.4
N/A	Flare Type LT	N/A	N/A	Flare Type RT	N/A
N/A	Flare Slope LT (%)	N/A	N/A	Flare Slope RT (%)	N/A
N/A	Flare Traversable LT?	N/A	N/A	Flare Traversable RT?	N/A
N/A	Landing Length (in)	N/A	N/A	DWS Provided?	N/A
N/A	Landing Width (in)	N/A	N/A	DWS Contrast?	N/A
N/A	Landing Slope (%)	N/A	N/A	DWS Length (in)	N/A
N/A	Landing X Slope (%)	N/A	N/A	DWS Full Width?	N/A
N/A	Landing Curb? (Y/N)	N/A	N/A	DWS Offset (in)	N/A
N/A	Shared Landing?	N/A			
N/A	Gutter Ponding?	N/A	N/A	Gutter Slope (%)	N/A
N/A	Gutter Lip Ht (in)	N/A	N/A	Gutter X Slope (%)	N/A
N/A	Painted X Walk1?	No	N/A	Painted X Walk2?	No
	X Walk 1 Direction	To S		X Walk 2 Direction	To E
N/A	X Walk 1 Width (in)	N/A	N/A	X Walk 2 Width (in)	N/A
	X Walk 1 Slope (%)	4.3		X Walk 2 Slope (%)	2.6
	X Walk 1 X Slope (%)	2.8		X Walk 2 X Slope (%)	2.0

N/A	Ramp inside XWalk1?	N/A	N/A	Ramp inside XWalk2?	N/A
	Road Slope (%)	1.2	N/A	Clear Space?	N/A
	Road X Slope (%)	4.3	N/A	Clear Space to XWalk (in)	N/A
N/A	Any Obstructions?	N/A	N/A	Storm Grate/Utility Hazard?	N/A
	Obstruction Type			Storm Grate/Utility Type	
		N/A			N/A
			Yes	Surface Condition? (G/P)	Good

**Remove & Replace Curb Ramp With Two New Directional Ramps or Equivalent.**

Total Cost: \$ 3200.00
